# Access Compliance Report

## Public Rights-of-Way

### (Curb Ramps)

Intersection ID: 24242	Main Street: BEVERLY_CREST_BV	Cross Street: PRESCOTT_POND_LN	Location: S
ADA ID: E982A6FA595B	Ramp Type: PerpDiag	Initial Pass/Fail: Fail	Overall Compliance: No
Severity Score: 13.75			
Codes/Mitigation Info/Possible Solution		Field Measurements/Component Compliance

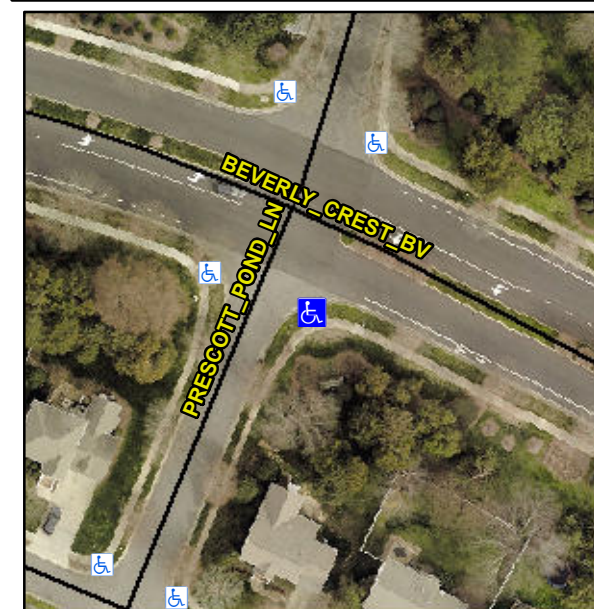
**Not Found, R304.2.2, R304.5.3**

Compliance	Description	Data	Compliance	Description	Data
N/A	Ramp Length (in)	96.0	No	Ramp Slope (%)	11.1
Yes	Ramp Width (in)	48.0	No	Ramp XSlope (%)	2.1
N/A	Flare Type LT	N/A	N/A	Flare Type RT	N/A
N/A	Flare Slope LT (%)	N/A	N/A	Flare Slope RT (%)	N/A
N/A	Flare Traversable LT?	N/A	N/A	Flare Traversable RT?	N/A
N/A	Landing Length (in)	N/A	N/A	DWS Provided?	N/A
N/A	Landing Width (in)	N/A	N/A	DWS Contrast?	N/A
N/A	Landing Slope (%)	N/A	N/A	DWS Length (in)	N/A
N/A	Landing X Slope (%)	N/A	N/A	DWS Full Width?	N/A
N/A	Landing Curb? (Y/N)	N/A	N/A	DWS Offset (in)	N/A
N/A	Shared Landing?	N/A			
N/A	Gutter Ponding?	N/A	N/A	Gutter Slope (%)	N/A
N/A	Gutter Lip Ht (in)	N/A	N/A	Gutter X Slope (%)	N/A
N/A	Painted X Walk1?	No	N/A	Painted X Walk2?	No
	X Walk 1 Direction	To NE		X Walk 2 Direction	To NW
N/A	X Walk 1 Width (in)	N/A	N/A	X Walk 2 Width (in)	N/A
	X Walk 1 Slope (%)	0.5		X Walk 2 Slope (%)	3.5
	X Walk 1 X Slope (%)	3.2		X Walk 2 X Slope (%)	0.7

N/A	Ramp inside XWalk1?	N/A	N/A	Ramp inside XWalk2?	N/A
	Road Slope (%)	2.6	N/A	Clear Space?	N/A
	Road X Slope (%)	0.1	N/A	Clear Space to XWalk (in)	N/A
N/A	Any Obstructions?	N/A	N/A	Storm Grate/Utility Hazard?	N/A
	Obstruction Type			Storm Grate/Utility Type	
		N/A			N/A
			Yes	Surface Condition? (G/P)	Good

**Remove & Replace Curb Ramp With Two New Directional Ramps or Equivalent.**
