Access Compliance Report

Public Rights-of-Way

(Curb Ramps)

Intersection ID: 10033070	Main Street: NORTH_COMMUNITY_HOUSE_RD	Cross Street: N/A	Location: NW
ADA ID: E98831A10E7E	Ramp Type: MedianPerp	Initial Pass/Fail: Fail	Overall Compliance: No
Severity Score: 12.5			
Codes/Mitigation Info/Possible Solution		Field Measurements/Component Compliance

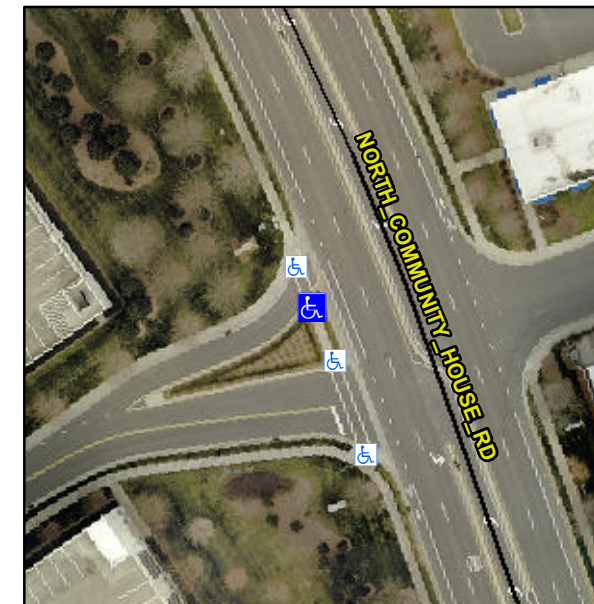
R304.2.2

Compliance	Description	Data	Compliance	Description	Data
N/A	Ramp Length (in)	73.0	No	Ramp Slope (%)	8.4
Yes	Ramp Width (in)	58.0	Yes	Ramp XSlope (%)	0.6
N/A	Flare Type LT	N/A	N/A	Flare Type RT	N/A
N/A	Flare Slope LT (%)	N/A	N/A	Flare Slope RT (%)	N/A
N/A	Flare Traversable LT?	N/A	N/A	Flare Traversable RT?	N/A
N/A	Landing Length (in)	N/A	N/A	DWS Provided?	N/A
N/A	Landing Width (in)	N/A	N/A	DWS Contrast?	N/A
N/A	Landing Slope (%)	N/A	N/A	DWS Length (in)	N/A
N/A	Landing X Slope (%)	N/A	N/A	DWS Full Width?	N/A
N/A	Landing Curb? (Y/N)	N/A	N/A	DWS Offset (in)	N/A
N/A	Shared Landing?	N/A			
N/A	Gutter Ponding?	N/A	N/A	Gutter Slope (%)	N/A
N/A	Gutter Lip Ht (in)	N/A	N/A	Gutter X Slope (%)	N/A
N/A	Painted X Walk1?	Yes	N/A	Painted X Walk2?	N/A
	X Walk 1 Direction	To NW		X Walk 2 Direction	N/A
N/A	X Walk 1 Width (in)	74.0	N/A	X Walk 2 Width (in)	N/A
	X Walk 1 Slope (%)	0.8		X Walk 2 Slope (%)	N/A
	X Walk 1 X Slope (%)	6.6		X Walk 2 X Slope (%)	N/A

Remove & Replace Entire Ramp.
