Access Compliance Report

Public Rights-of-Way

(Curb Ramps)

Intersection ID: 29706	Main Street: SIMFIELD_CHURCH_RD	Cross Street: WEDDINGTON_RIDGE_LN	Location: E
ADA ID: E9902E0D2CA8	Ramp Type: Perp	Initial Pass/Fail: Fail	Overall Compliance: No
		Severity Score: 8.75

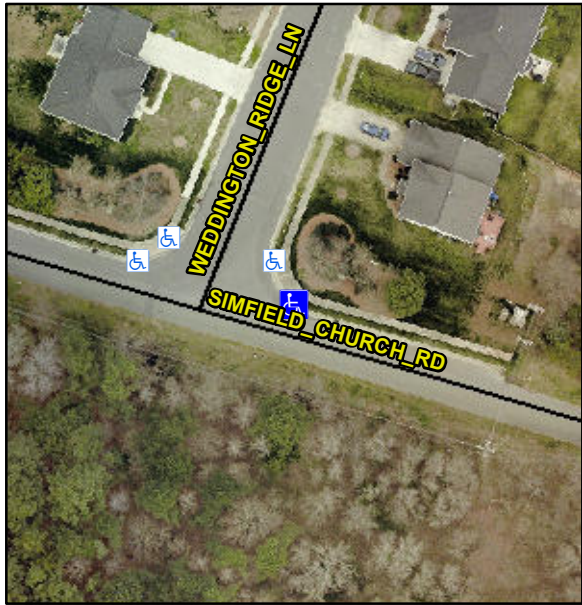
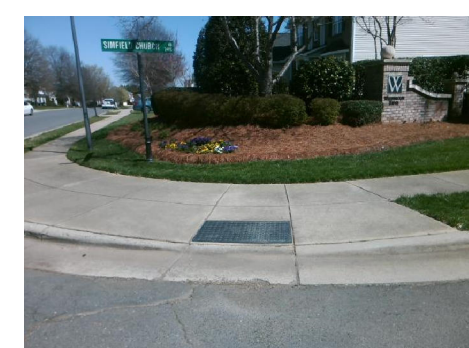
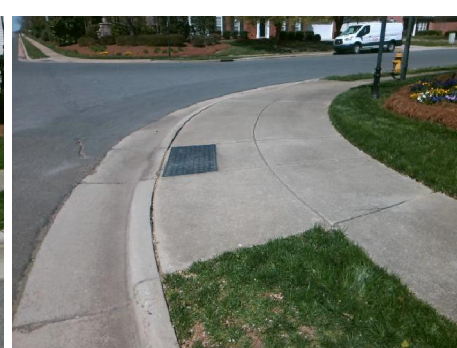
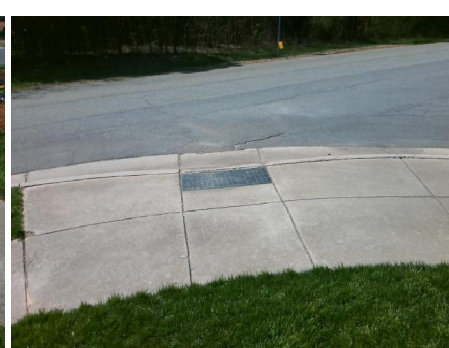
Possible Solutions:		Compliance	Description	Data	Compliance	Description	Data
	Remove & Replace Entire Ramp.		N/A	Ramp Length (in)	48.0	Yes	Ramp Slope (%)	7.1
			No	Ramp Width (in)	41.0	Yes	Ramp XSlope (%)	1.1
			N/A	Flare Type LT	N/A	N/A	Flare Type RT	N/A
			N/A	Flare Slope LT (%)	N/A	N/A	Flare Slope RT (%)	N/A
			N/A	Flare Traversable LT?	N/A	N/A	Flare Traversable RT?	N/A
			N/A	Landing Length (in)	N/A	N/A	DWS Provided?	N/A
			N/A	Landing Width (in)	N/A	N/A	DWS Contrast?	N/A
			N/A	Landing Slope (%)	N/A	N/A	DWS Length (in)	N/A
			N/A	Landing X Slope (%)	N/A	N/A	DWS Full Width?	N/A
Surveyor Notes:			N/A	Landing Curb? (Y/N)	N/A	N/A	DWS Offset (in)	N/A
N/A			N/A	Shared Landing?	N/A			
PROW/ADA:			N/A	Gutter Ponding?	N/A	N/A	Gutter Slope (%)	N/A
Not Found, R304.5.1			N/A	Gutter Lip Ht (in)	N/A	N/A	Gutter X Slope (%)	N/A

N/A	Painted X Walk1?	No	N/A	Painted X Walk2?	N/A
				X Walk 1 Direction	To SW		X Walk 2 Direction	N/A
			N/A	X Walk 1 Width (in)	N/A	N/A	X Walk 2 Width (in)	N/A
				X Walk 1 Slope (%)	0.3		X Walk 2 Slope (%)	N/A
				X Walk 1 X Slope (%)	0.4		X Walk 2 X Slope (%)	N/A
			N/A	Ramp inside XWalk1?	N/A	N/A	Ramp inside XWalk2?	N/A
				Road Slope (%)	0.3	N/A	Clear Space?	N/A
				Road X Slope (%)	0.4	N/A	Clear Space to XWalk (in)	N/A
			N/A	Any Obstructions?	N/A	N/A	Storm Grate/Utility Hazard?	N/A
				Obstruction Type			Storm Grate/Utility Type	
						N/A		N/A
						Yes	Surface Condition? (G/P)	Good
