Access Compliance Report

Public Rights-of-Way

(Curb Ramps)

Intersection ID: 19374	Main Street: SHARON_RD	Cross Street: RED_FOX_TL	Location: SE
ADA ID: E9903666E106	Ramp Type: PerpDiag	Initial Pass/Fail: Fail	Overall Compliance: No
Severity Score: 8.75			
Codes/Mitigation Info/Possible Solution		Field Measurements/Component Compliance

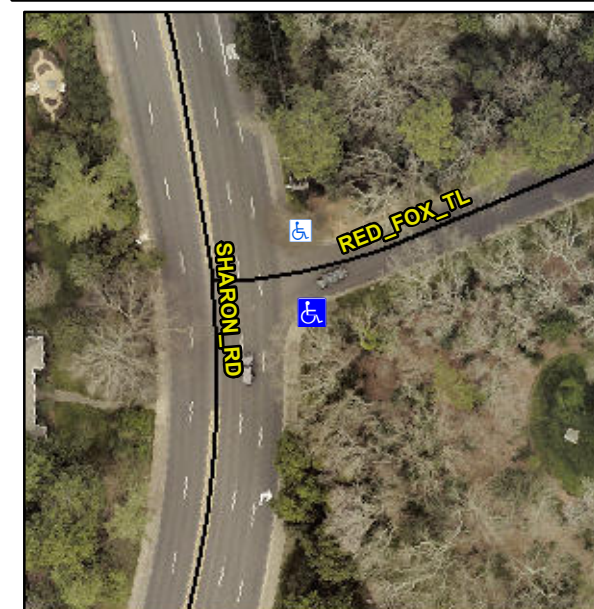
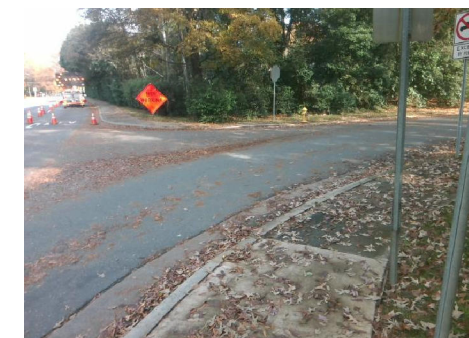
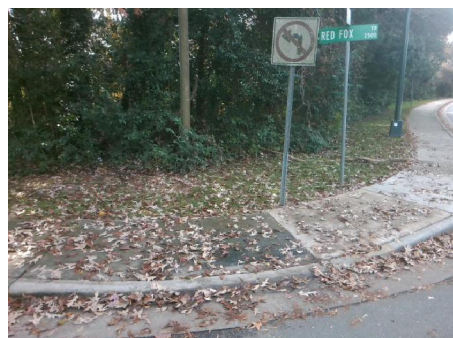
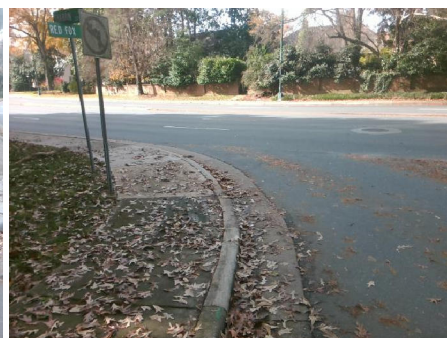
Compliance	Description	Data	Compliance	Description	Data
N/A	Ramp Length (in)	59.0	Yes	Ramp Slope (%)	7.6
No	Ramp Width (in)	40.0	Yes	Ramp XSlope (%)	0.6
N/A	Flare Type LT	N/A	N/A	Flare Type RT	N/A
N/A	Flare Slope LT (%)	N/A	N/A	Flare Slope RT (%)	N/A
N/A	Flare Traversable LT?	N/A	N/A	Flare Traversable RT?	N/A
N/A	Landing Length (in)	N/A	N/A	DWS Provided?	N/A
N/A	Landing Width (in)	N/A	N/A	DWS Contrast?	N/A
N/A	Landing Slope (%)	N/A	N/A	DWS Length (in)	N/A
N/A	Landing X Slope (%)	N/A	N/A	DWS Full Width?	N/A
N/A	Landing Curb? (Y/N)	N/A	N/A	DWS Offset (in)	N/A
N/A	Shared Landing?	N/A			
N/A	Gutter Ponding?	N/A	N/A	Gutter Slope (%)	N/A
N/A	Gutter Lip Ht (in)	N/A	N/A	Gutter X Slope (%)	N/A
N/A	Painted X Walk1?	No	N/A	Painted X Walk2?	No
	X Walk 1 Direction	To N		X Walk 2 Direction	To W
N/A	X Walk 1 Width (in)	N/A	N/A	X Walk 2 Width (in)	N/A
	X Walk 1 Slope (%)	2.8		X Walk 2 Slope (%)	0.1
	X Walk 1 X Slope (%)	0.3		X Walk 2 X Slope (%)	2.1

N/A	Ramp inside XWalk1?	N/A	N/A	Ramp inside XWalk2?	N/A
	Road Slope (%)	1.7	N/A	Clear Space?	N/A
	Road X Slope (%)	3.3	N/A	Clear Space to XWalk (in)	N/A
N/A	Any Obstructions?	N/A	N/A	Storm Grate/Utility Hazard?	N/A
	Obstruction Type			Storm Grate/Utility Type	
		N/A			N/A
		Yes		Surface Condition? (G/P)	Good

Possible Solutions:

Remove & Replace Curb Ramp With Two New Directional Ramps or Equivalent.

R304.5.1

Total Cost: \$ 3200.00
