# Access Compliance Report

## Public Rights-of-Way

### (Curb Ramps)

Intersection ID: 15450	Main Street: ALBEMARLE_RD	Cross Street: PIERSON_DR	Location: SE
ADA ID: E9A71B25D774	Ramp Type: Perp	Initial Pass/Fail: Fail	Overall Compliance: No
Severity Score: 8.75			
Codes/Mitigation Info/Possible Solution		Field Measurements/Component Compliance

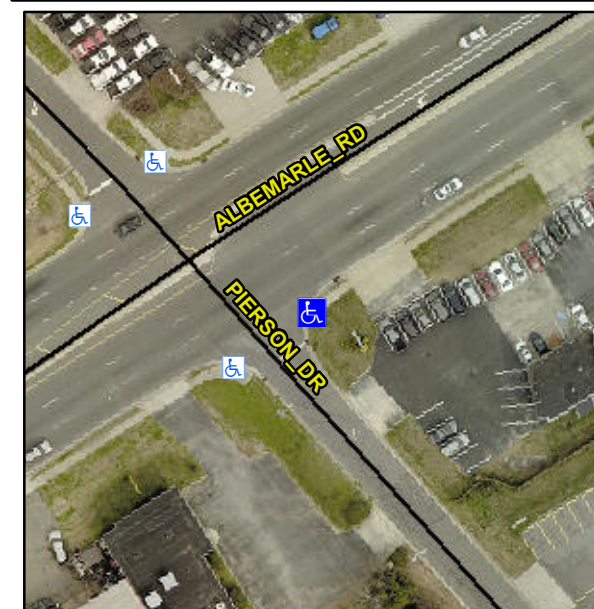
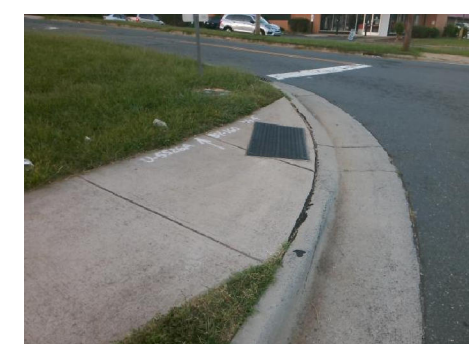
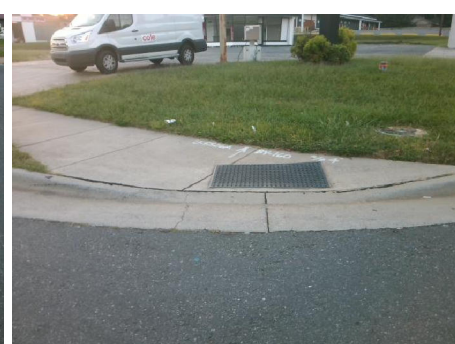
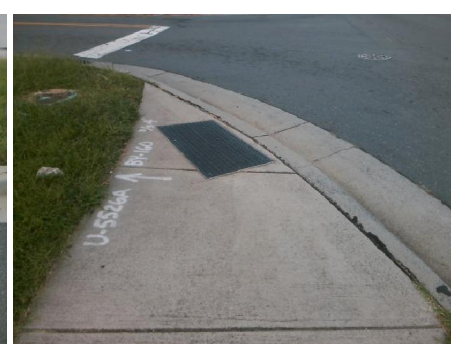
**Not Found, R304.5.1**

Compliance	Description	Data	Compliance	Description	Data
N/A	Ramp Length (in)	39.5	Yes	Ramp Slope (%)	8.0
No	Ramp Width (in)	47.0	Yes	Ramp XSlope (%)	1.5
N/A	Flare Type LT	N/A	N/A	Flare Type RT	N/A
N/A	Flare Slope LT (%)	N/A	N/A	Flare Slope RT (%)	N/A
N/A	Flare Traversable LT?	N/A	N/A	Flare Traversable RT?	N/A
N/A	Landing Length (in)	N/A	N/A	DWS Provided?	N/A
N/A	Landing Width (in)	N/A	N/A	DWS Contrast?	N/A
N/A	Landing Slope (%)	N/A	N/A	DWS Length (in)	N/A
N/A	Landing X Slope (%)	N/A	N/A	DWS Full Width?	N/A
N/A	Landing Curb? (Y/N)	N/A	N/A	DWS Offset (in)	N/A
N/A	Shared Landing?	N/A			
N/A	Gutter Ponding?	N/A	N/A	Gutter Slope (%)	N/A
N/A	Gutter Lip Ht (in)	N/A	N/A	Gutter X Slope (%)	N/A
N/A	Painted X Walk1?	No	N/A	Painted X Walk2?	N/A
	X Walk 1 Direction	To W		X Walk 2 Direction	N/A
N/A	X Walk 1 Width (in)	N/A	N/A	X Walk 2 Width (in)	N/A
	X Walk 1 Slope (%)	2.3		X Walk 2 Slope (%)	N/A
	X Walk 1 X Slope (%)	4.5		X Walk 2 X Slope (%)	N/A

N/A	Ramp inside XWalk1?	N/A	N/A	Ramp inside XWalk2?	N/A
	Road Slope (%)	N/A	N/A	Clear Space?	N/A
	Road X Slope (%)	N/A	N/A	Clear Space to XWalk (in)	N/A
N/A	Any Obstructions?	N/A	N/A	Storm Grate/Utility Hazard?	N/A
	Obstruction Type			Storm Grate/Utility Type	
		N/A			N/A
			Yes	Surface Condition? (G/P)	Good

**Remove & Replace Entire Ramp.**
