# Access Compliance Report

## Public Rights-of-Way

### (Curb Ramps)

Intersection ID: 19169	Main Street: LIVINGSTON_DR	Cross Street: SARDIS_RD	Location: NE
ADA ID: E9ADC52E5F2E	Ramp Type: Perp	Initial Pass/Fail: Fail	Overall Compliance: No
Codes/Mitigation Info/Possible Solution			Severity Score: 12.5
			Field Measurements/Component Compliance

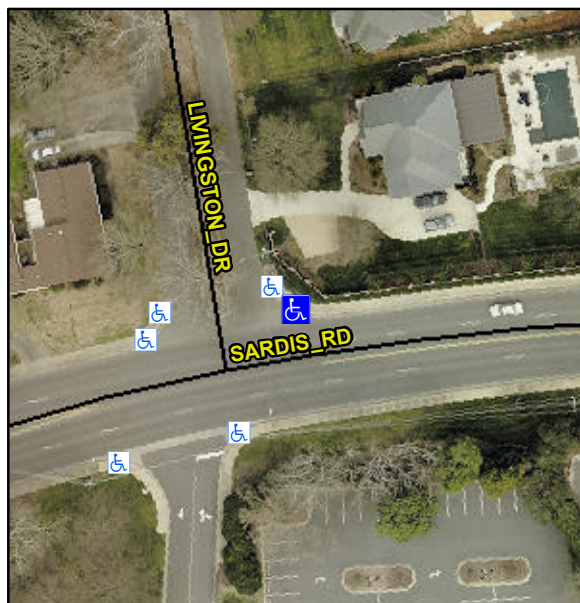
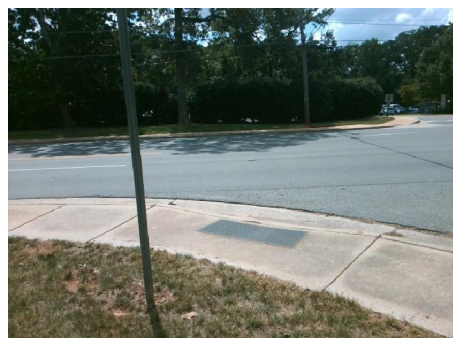
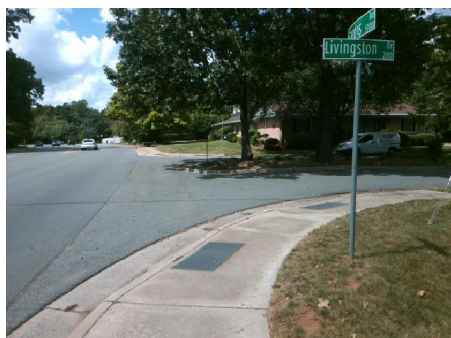
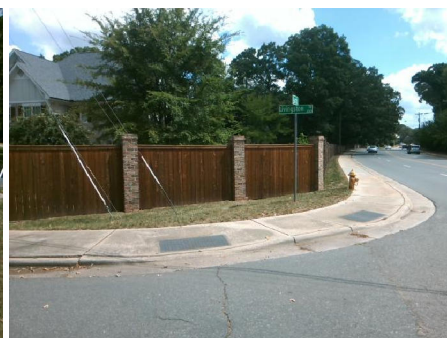
Compliance	Description	Data	Compliance	Description	Data
N/A	Ramp Length (in)	60.0	No	Ramp Slope (%)	10.1
Yes	Ramp Width (in)	48.0	Yes	Ramp XSlope (%)	0.6
N/A	Flare Type LT	N/A	N/A	Flare Type RT	N/A
N/A	Flare Slope LT (%)	N/A	N/A	Flare Slope RT (%)	N/A
N/A	Flare Traversable LT?	N/A	N/A	Flare Traversable RT?	N/A
N/A	Landing Length (in)	N/A	N/A	DWS Provided?	N/A
N/A	Landing Width (in)	N/A	N/A	DWS Contrast?	N/A
N/A	Landing Slope (%)	N/A	N/A	DWS Length (in)	N/A
N/A	Landing X Slope (%)	N/A	N/A	DWS Full Width?	N/A
N/A	Landing Curb? (Y/N)	N/A	N/A	DWS Offset (in)	N/A
N/A	Shared Landing?	N/A			
N/A	Gutter Ponding?	N/A	N/A	Gutter Slope (%)	N/A
N/A	Gutter Lip Ht (in)	N/A	N/A	Gutter X Slope (%)	N/A
N/A	Painted X Walk1?	No	N/A	Painted X Walk2?	N/A
	X Walk 1 Direction	To SW		X Walk 2 Direction	N/A
N/A	X Walk 1 Width (in)	N/A	N/A	X Walk 2 Width (in)	N/A
	X Walk 1 Slope (%)	2.5		X Walk 2 Slope (%)	N/A
	X Walk 1 X Slope (%)	0.9		X Walk 2 X Slope (%)	N/A

N/A	Ramp inside XWalk1?	N/A	N/A	Ramp inside XWalk2?	N/A
	Road Slope (%)	N/A	N/A	Clear Space?	N/A
	Road X Slope (%)	N/A	N/A	Clear Space to XWalk (in)	N/A
N/A	Any Obstructions?	N/A	N/A	Storm Grate/Utility Hazard?	N/A
	Obstruction Type			Storm Grate/Utility Type	
		N/A			N/A
			Yes	Surface Condition? (G/P)	Good

**Remove & Replace Entire Ramp.**
