Access Compliance Report

Public Rights-of-Way (Curb Ramps)

Intersection ID: 10018553	Main Street: LIGON_CT	Cross Street: N/A	Location: NE
ADA ID: E9B189E6D3C6	Ramp Type: Perp	Initial Pass/Fail: Fail	Overall Compliance: No
			Severity Score: 21.25

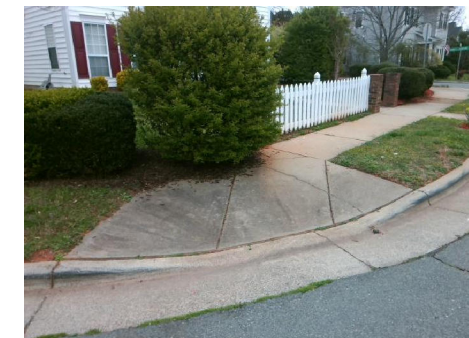
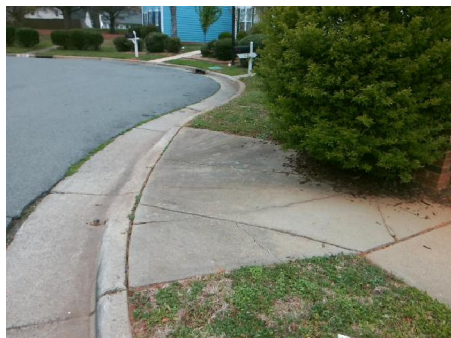
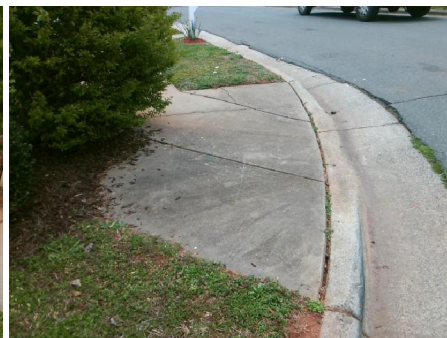
Not Found, R304.5.1, R304.2.2

Compliance	Description	Data	Compliance	Description	Data
N/A	Ramp Length (in)	74.0	No	Ramp Slope (%)	9.2
No	Ramp Width (in)	47.0	Yes	Ramp XSlope (%)	0.1
N/A	Flare Type LT	N/A	N/A	Flare Type RT	N/A
N/A	Flare Slope LT (%)	N/A	N/A	Flare Slope RT (%)	N/A
N/A	Flare Traversable LT?	N/A	N/A	Flare Traversable RT?	N/A
N/A	Landing Length (in)	N/A	N/A	DWS Provided?	N/A
N/A	Landing Width (in)	N/A	N/A	DWS Contrast?	N/A
N/A	Landing Slope (%)	N/A	N/A	DWS Length (in)	N/A
N/A	Landing X Slope (%)	N/A	N/A	DWS Full Width?	N/A
N/A	Landing Curb? (Y/N)	N/A	N/A	DWS Offset (in)	N/A
N/A	Shared Landing?	N/A			
N/A	Gutter Ponding?	N/A	N/A	Gutter Slope (%)	N/A
N/A	Gutter Lip Ht (in)	N/A	N/A	Gutter X Slope (%)	N/A
N/A	Painted X Walk1?	No	N/A	Painted X Walk2?	N/A
	X Walk 1 Direction	To W		X Walk 2 Direction	N/A
N/A	X Walk 1 Width (in)	N/A	N/A	X Walk 2 Width (in)	N/A
	X Walk 1 Slope (%)	2.3		X Walk 2 Slope (%)	N/A
	X Walk 1 X Slope (%)	1.0		X Walk 2 X Slope (%)	N/A

N/A	Ramp inside XWalk1?	N/A	N/A	Ramp inside XWalk2?	N/A
	Road Slope (%)	N/A	N/A	Clear Space?	N/A
	Road X Slope (%)	N/A	N/A	Clear Space to XWalk (in)	N/A
N/A	Any Obstructions?	N/A	N/A	Storm Grate/Utility Hazard?	N/A
	Obstruction Type			Storm Grate/Utility Type	
		N/A			N/A
			Yes	Surface Condition? (G/P)	Good

Remove & Replace Entire Ramp.
