Access Compliance Report

Public Rights-of-Way

(Curb Ramps)

Intersection ID: 10023914	Main Street: CONFERENCE_DR	Cross Street: N/A	Location: NW
ADA ID: E9B3DE6ADA57	Ramp Type: Perp	Initial Pass/Fail: Fail	Overall Compliance: No
Severity Score: 13.75			
Codes/Mitigation Info/Possible Solution		Field Measurements/Component Compliance

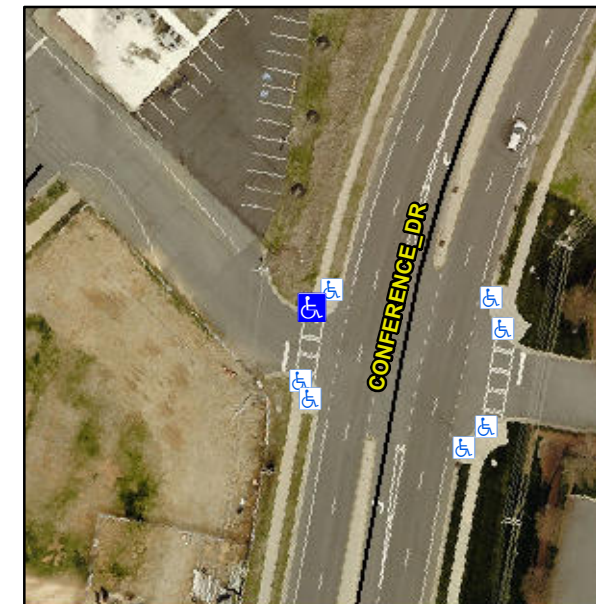
R304.2.2, R304.5.3

Compliance	Description	Data	Compliance	Description	Data
N/A	Ramp Length (in)	66.0	No	Ramp Slope (%)	9.0
Yes	Ramp Width (in)	48.0	No	Ramp XSlope (%)	5.0
N/A	Flare Type LT	N/A	N/A	Flare Type RT	N/A
N/A	Flare Slope LT (%)	N/A	N/A	Flare Slope RT (%)	N/A
N/A	Flare Traversable LT?	N/A	N/A	Flare Traversable RT?	N/A
N/A	Landing Length (in)	N/A	N/A	DWS Provided?	N/A
N/A	Landing Width (in)	N/A	N/A	DWS Contrast?	N/A
N/A	Landing Slope (%)	N/A	N/A	DWS Length (in)	N/A
N/A	Landing X Slope (%)	N/A	N/A	DWS Full Width?	N/A
N/A	Landing Curb? (Y/N)	N/A	N/A	DWS Offset (in)	N/A
N/A	Shared Landing?	N/A			
N/A	Gutter Ponding?	N/A	N/A	Gutter Slope (%)	N/A
N/A	Gutter Lip Ht (in)	N/A	N/A	Gutter X Slope (%)	N/A
N/A	Painted X Walk1?	Yes	N/A	Painted X Walk2?	N/A
	X Walk 1 Direction	To S		X Walk 2 Direction	N/A
N/A	X Walk 1 Width (in)	111.0	N/A	X Walk 2 Width (in)	N/A
	X Walk 1 Slope (%)	0.1		X Walk 2 Slope (%)	N/A
	X Walk 1 X Slope (%)	4.1		X Walk 2 X Slope (%)	N/A

N/A	Ramp inside XWalk1?	Yes	N/A	Ramp inside XWalk2?	N/A
	Road Slope (%)	N/A	N/A	Clear Space?	N/A
	Road X Slope (%)	N/A	N/A	Clear Space to XWalk (in)	N/A
N/A	Any Obstructions?	N/A	N/A	Storm Grate/Utility Hazard?	N/A
	Obstruction Type			Storm Grate/Utility Type	
		N/A			N/A
		Yes		Surface Condition? (G/P)	Good

Possible Solutions:

Remove & Replace Entire Ramp.

Total Cost: \$ 1850.00
