# Access Compliance Report

## Public Rights-of-Way

### (Curb Ramps)

Intersection ID: 44487	Main Street: REAMES_RD	Cross Street: FINN_HALL_AV	Location: W
ADA ID: E9B8CB006F23	Ramp Type: Perp	Initial Pass/Fail: Fail	Overall Compliance: No
		Severity Score: 10

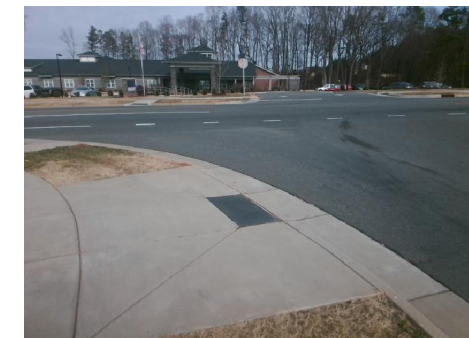
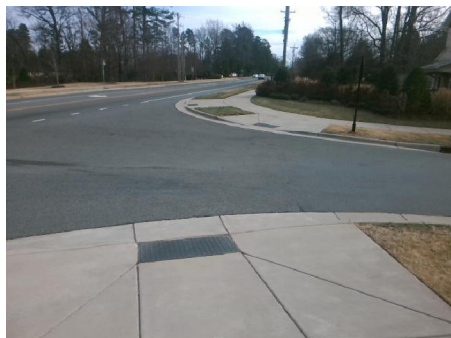
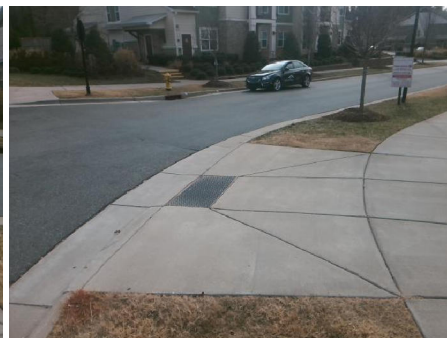
**Not Found, R304.5.1, R304.5.3**

Compliance	Description	Data	Compliance	Description	Data
N/A	Ramp Length (in)	96.0	Yes	Ramp Slope (%)	7.6
No	Ramp Width (in)	47.5	No	Ramp XSlope (%)	2.6
N/A	Flare Type LT	N/A	N/A	Flare Type RT	N/A
N/A	Flare Slope LT (%)	N/A	N/A	Flare Slope RT (%)	N/A
N/A	Flare Traversable LT?	N/A	N/A	Flare Traversable RT?	N/A
N/A	Landing Length (in)	N/A	N/A	DWS Provided?	N/A
N/A	Landing Width (in)	N/A	N/A	DWS Contrast?	N/A
N/A	Landing Slope (%)	N/A	N/A	DWS Length (in)	N/A
N/A	Landing X Slope (%)	N/A	N/A	DWS Full Width?	N/A
N/A	Landing Curb? (Y/N)	N/A	N/A	DWS Offset (in)	N/A
N/A	Shared Landing?	N/A			
N/A	Gutter Ponding?	N/A	N/A	Gutter Slope (%)	N/A
N/A	Gutter Lip Ht (in)	N/A	N/A	Gutter X Slope (%)	N/A
N/A	Painted X Walk1?	No	N/A	Painted X Walk2?	N/A
	X Walk 1 Direction	To S		X Walk 2 Direction	N/A
N/A	X Walk 1 Width (in)	N/A	N/A	X Walk 2 Width (in)	N/A
	X Walk 1 Slope (%)	0.9		X Walk 2 Slope (%)	N/A
	X Walk 1 X Slope (%)	2.2		X Walk 2 X Slope (%)	N/A

N/A	Ramp inside XWalk1?	N/A	N/A	Ramp inside XWalk2?	N/A
	Road Slope (%)	N/A	N/A	Clear Space?	N/A
	Road X Slope (%)	N/A	N/A	Clear Space to XWalk (in)	N/A
N/A	Any Obstructions?	N/A	N/A	Storm Grate/Utility Hazard?	N/A
	Obstruction Type			Storm Grate/Utility Type	
		N/A			N/A
			Yes	Surface Condition? (G/P)	Good

**Remove & Replace Entire Ramp.**

Total Cost: \$ 1850.00
