Intersection ID: 11163	Main Street: EVERETT_PL	Cross Street: UNION_ST	Location:	SE
ADA ID: E9BAF58802A9	Ramp Type: Perp	Initial Pass/Fail: Fail	Overall Compliance: No	Severity Score: 21.25

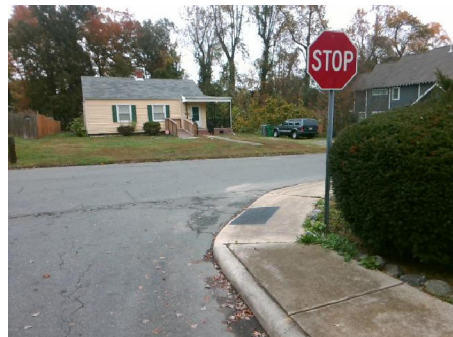
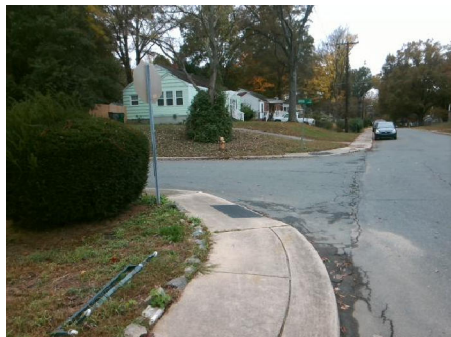
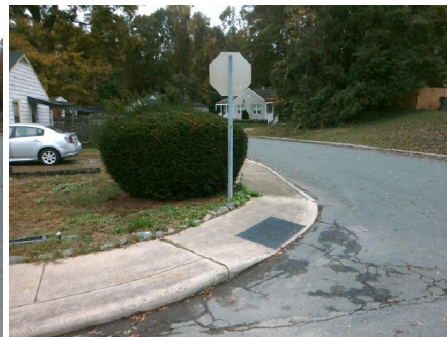
Not Found, R304.5.1, R304.2.2

Compliance	Description	Data	Compliance	Description	Data
N/A	Ramp Length (in)	53.0	No	Ramp Slope (%)	10.1
No	Ramp Width (in)	46.0	Yes	Ramp XSlope (%)	1.8
N/A	Flare Type LT	N/A	N/A	Flare Type RT	N/A
N/A	Flare Slope LT (%)	N/A	N/A	Flare Slope RT (%)	N/A
N/A	Flare Traversable LT?	N/A	N/A	Flare Traversable RT?	N/A
N/A	Landing Length (in)	N/A	N/A	DWS Provided?	N/A
N/A	Landing Width (in)	N/A	N/A	DWS Contrast?	N/A
N/A	Landing Slope (%)	N/A	N/A	DWS Length (in)	N/A
N/A	Landing X Slope (%)	N/A	N/A	DWS Full Width?	N/A
N/A	Landing Curb? (Y/N)	N/A	N/A	DWS Offset (in)	N/A
N/A	Shared Landing?	N/A			
N/A	Gutter Ponding?	N/A	N/A	Gutter Slope (%)	N/A
N/A	Gutter Lip Ht (in)	0.5	N/A	Gutter X Slope (%)	N/A
N/A	Painted X Walk1?	No	N/A	Painted X Walk2?	N/A
	X Walk 1 Direction	To W		X Walk 2 Direction	N/A
N/A	X Walk 1 Width (in)	N/A	N/A	X Walk 2 Width (in)	N/A
	X Walk 1 Slope (%)	3.3		X Walk 2 Slope (%)	N/A
	X Walk 1 X Slope (%)	1.0		X Walk 2 X Slope (%)	N/A

N/A	Ramp inside XWalk1?	N/A	N/A	Ramp inside XWalk2?	N/A
	Road Slope (%)	N/A	N/A	Clear Space?	N/A
	Road X Slope (%)	N/A	N/A	Clear Space to XWalk (in)	N/A
N/A	Any Obstructions?	N/A	N/A	Storm Grate/Utility Hazard?	N/A
	Obstruction Type			Storm Grate/Utility Type	
		N/A			N/A
			Yes	Surface Condition? (G/P)	Good

Remove & Replace Entire Ramp.

Total Cost: \$ 1850.00
