# Access Compliance Report

## Public Rights-of-Way

| Intersection ID: 14213 | Main Street: CENTRAL_AV | Cross Street: ROSEHAVEN_DR | Location: NE |
| ADA ID: E9C7836BC1B5 | Ramp Type: Para | Initial Pass/Fail: Pass | Overall Compliance: No |

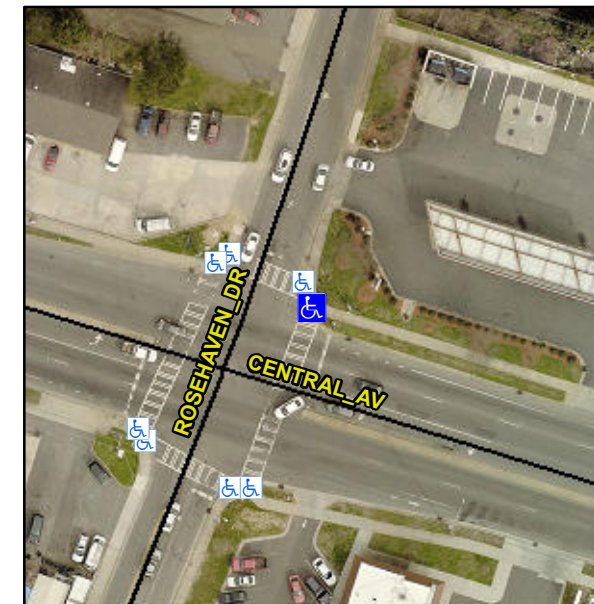
**LT RP < 5%**

**Not Found, R304.5.3, R304.2.1, R304.2.2-Perp, R304.3.2-Para, R305.1.4**

| Compliance | Description | Data | Compliance | Description | Data |
|---|---|---|---|---|---|
| No | Ramp XSlope LT (%) | 4.0 | Yes | Ramp XSlope RT (%) | 1.9 |
| No | Landing Width (in) | 34.0 | Yes | DWS Contrast? | Yes |
| No | Landing Slope (%) | 3.3 | Yes | DWS Length (in) | 28.0 |
| No | Landing X Slope (%) | 2.6 | No | DWS Full Width? | No |

**Remove & Replace Entire Ramp.**
