Intersection ID: 11233 Main Street: FOXFORD_PL Cross Street: TIPPERARY_PL Location: NW

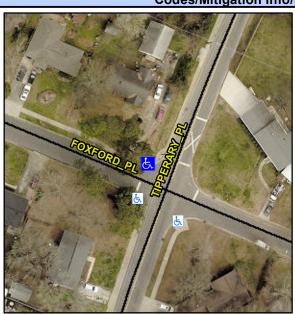
Total Cost: \$ 1600.00

Field Measurements/Component Compliance Compliance Description Data Compliance Description Data					
N/A	Ramp Length LT (in)	19.5	N/A	Ramp Length RT (in)	16.5
No	Ramp Width LT (in)	47.0	No	Ramp Width RT (in)	47.0
Yes	Ramp Slope LT (%)	6.1	No	Ramp Slope RT (%)	11.1
No	Ramp XSlope LT (%)	6.7	No	Ramp XSlope RT (%)	5.2
N/A	Landing Length (in)	N/A	N/A	DWS Provided?	N/A
N/A	Landing Width (in)	N/A	N/A	DWS Contrast?	N/A
N/A	Landing Slope (%)	N/A	N/A	DWS Length (in)	N/A
N/A	Landing X Slope (%)	N/A	N/A	DWS Full Width?	N/A
N/A	Landing Curb? (Y/N)	N/A	N/A	DWS Offset (in)	N/A
N/A	Shared Landing?	N/A	, .	5 (m)	
N/A	Gutter Ponding?	N/A	N/A	Gutter Slope (%)	N/A
N/A	Gutter Lip Ht (in)	1.0	N/A	Gutter X Slope (%)	N/A
N/A	Painted X Walk1?	No	N/A	Painted X Walk2?	N/A
	X Walk 1 Direction	To S		X Walk 2 Direction	N/A
N/A	X Walk 1 Width (in)	N/A	N/A	X Walk 2 Width (in)	N/A
	X Walk 1 Slope (%)	1.6		X Walk 2 Slope (%)	N/A
	X Walk 1 X Slope (%)	3.6		X Walk 2 X Slope (%)	N/A

Possible Solutions:
