# Access Compliance Report

## Public Rights-of-Way

### (Curb Ramps)

Intersection ID: 13806	Main Street: S_TRYON_ST	Cross Street: WEST_BV	Location: S
ADA ID: E9E3288FB537	Ramp Type: Perp	Initial Pass/Fail: Fail	Overall Compliance: No
		Severity Score: 8.75

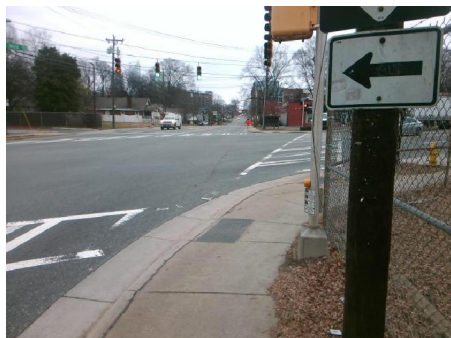
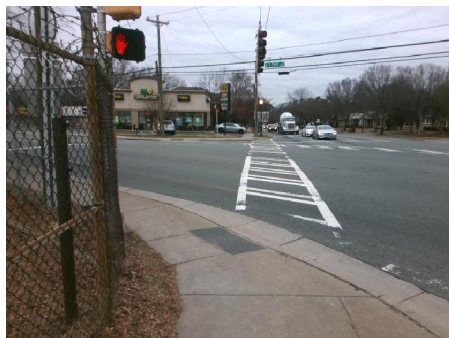
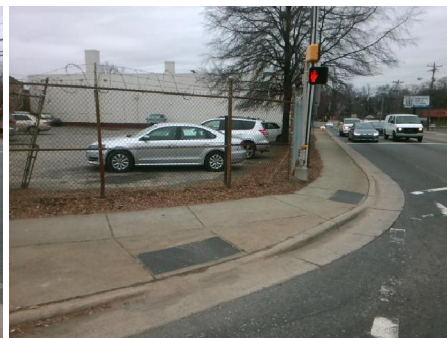
**Not Found, R304.5.1**

Compliance	Description	Data	Compliance	Description	Data
N/A	Ramp Length (in)	57.0	Yes	Ramp Slope (%)	6.7
No	Ramp Width (in)	36.0	Yes	Ramp XSlope (%)	1.8
N/A	Flare Type LT	N/A	N/A	Flare Type RT	N/A
N/A	Flare Slope LT (%)	N/A	N/A	Flare Slope RT (%)	N/A
N/A	Flare Traversable LT?	N/A	N/A	Flare Traversable RT?	N/A
N/A	Landing Length (in)	N/A	N/A	DWS Provided?	N/A
N/A	Landing Width (in)	N/A	N/A	DWS Contrast?	N/A
N/A	Landing Slope (%)	N/A	N/A	DWS Length (in)	N/A
N/A	Landing X Slope (%)	N/A	N/A	DWS Full Width?	N/A
N/A	Landing Curb? (Y/N)	N/A	N/A	DWS Offset (in)	N/A
N/A	Shared Landing?	N/A			
N/A	Gutter Ponding?	N/A	N/A	Gutter Slope (%)	N/A
N/A	Gutter Lip Ht (in)	N/A	N/A	Gutter X Slope (%)	N/A
N/A	Painted X Walk1?	Yes	N/A	Painted X Walk2?	N/A
	X Walk 1 Direction	To NW		X Walk 2 Direction	N/A
N/A	X Walk 1 Width (in)	58.0	N/A	X Walk 2 Width (in)	N/A
	X Walk 1 Slope (%)	3.3		X Walk 2 Slope (%)	N/A
	X Walk 1 X Slope (%)	2.5		X Walk 2 X Slope (%)	N/A

N/A	Ramp inside XWalk1?	Yes	N/A	Ramp inside XWalk2?	N/A
	Road Slope (%)	N/A	N/A	Clear Space?	N/A
	Road X Slope (%)	N/A	N/A	Clear Space to XWalk (in)	N/A
N/A	Any Obstructions?	N/A	N/A	Storm Grate/Utility Hazard?	N/A
	Obstruction Type			Storm Grate/Utility Type	
		N/A			N/A
			Yes	Surface Condition? (G/P)	Good

**Remove & Replace Entire Ramp.**
