# Access Compliance Report

## Public Rights-of-Way

### (Curb Ramps)

Intersection ID: 3651	Main Street: CHIPSTONE_RD	Cross Street: FOUNTAINGROVE_DR	Location:	S
ADA ID: E9E5A8B9A684	Ramp Type: Perp	Initial Pass/Fail: Fail	Overall Compliance: No	Severity Score: 37.5
Codes/Mitigation Info/Possible Solution		Field Measurements/Component Compliance

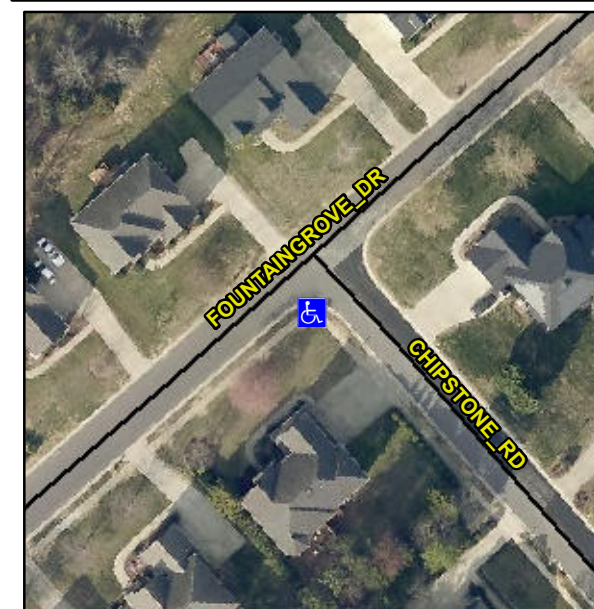
**Not Found, R304.2.2, R304.5.3**

Compliance	Description	Data	Compliance	Description	Data
N/A	Ramp Length (in)	50.0	No	Ramp Slope (%)	9.1
Yes	Ramp Width (in)	96.0	No	Ramp XSlope (%)	9.4
N/A	Flare Type LT	N/A	N/A	Flare Type RT	N/A
N/A	Flare Slope LT (%)	N/A	N/A	Flare Slope RT (%)	N/A
N/A	Flare Traversable LT?	N/A	N/A	Flare Traversable RT?	N/A
N/A	Landing Length (in)	N/A	N/A	DWS Provided?	N/A
N/A	Landing Width (in)	N/A	N/A	DWS Contrast?	N/A
N/A	Landing Slope (%)	N/A	N/A	DWS Length (in)	N/A
N/A	Landing X Slope (%)	N/A	N/A	DWS Full Width?	N/A
N/A	Landing Curb? (Y/N)	N/A	N/A	DWS Offset (in)	N/A
N/A	Shared Landing?	N/A			
N/A	Gutter Ponding?	N/A	N/A	Gutter Slope (%)	N/A
N/A	Gutter Lip Ht (in)	N/A	N/A	Gutter X Slope (%)	N/A
N/A	Painted X Walk1?	No	N/A	Painted X Walk2?	N/A
	X Walk 1 Direction	To N		X Walk 2 Direction	N/A
N/A	X Walk 1 Width (in)	N/A	N/A	X Walk 2 Width (in)	N/A
	X Walk 1 Slope (%)	1.8		X Walk 2 Slope (%)	N/A
	X Walk 1 X Slope (%)	5.2		X Walk 2 X Slope (%)	N/A

N/A	Ramp inside XWalk1?	N/A	N/A	Ramp inside XWalk2?	N/A
	Road Slope (%)	N/A	N/A	Clear Space?	N/A
	Road X Slope (%)	N/A	N/A	Clear Space to XWalk (in)	N/A
N/A	Any Obstructions?	N/A	N/A	Storm Grate/Utility Hazard?	N/A
	Obstruction Type			Storm Grate/Utility Type	
		N/A			N/A
			Yes	Surface Condition? (G/P)	Good

**Remove & Replace Entire Ramp.**
