Access Compliance Report

Public Rights-of-Way

(Curb Ramps)

Intersection ID: 11771	Main Street: SHAMROCK_DR	Cross Street: WINEDALE_LN	Location: S
ADA ID: E9EA08DE45E4	Ramp Type: PerpDiag	Initial Pass/Fail: Fail	Overall Compliance: No
Codes/Mitigation Info/Possible Solution		Field Measurements/Component Compliance	
Severity Score: 33.75

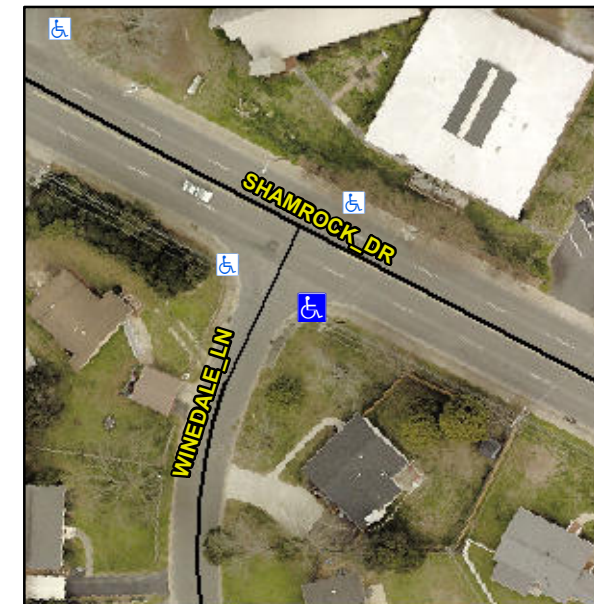
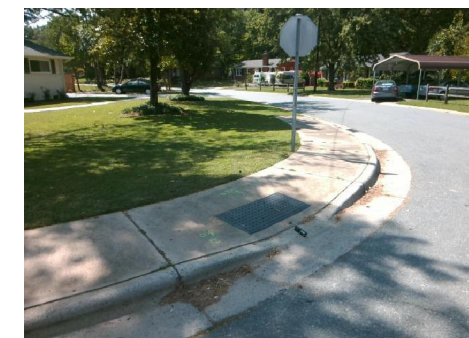
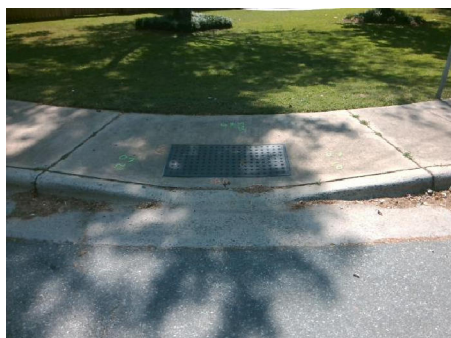
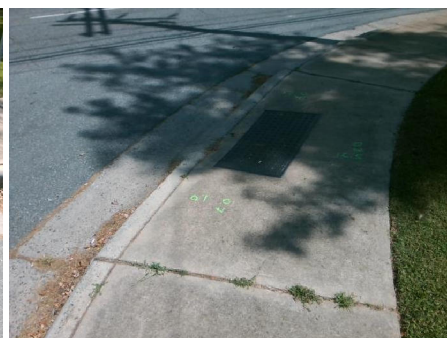
Not Found, R304.5.1, R304.2.2

Compliance	Description	Data	Compliance	Description	Data
N/A	Ramp Length (in)	60.0	No	Ramp Slope (%)	12.5
No	Ramp Width (in)	38.0	Yes	Ramp XSlope (%)	0.8
N/A	Flare Type LT	N/A	N/A	Flare Type RT	N/A
N/A	Flare Slope LT (%)	N/A	N/A	Flare Slope RT (%)	N/A
N/A	Flare Traversable LT?	N/A	N/A	Flare Traversable RT?	N/A
N/A	Landing Length (in)	N/A	N/A	DWS Provided?	N/A
N/A	Landing Width (in)	N/A	N/A	DWS Contrast?	N/A
N/A	Landing Slope (%)	N/A	N/A	DWS Length (in)	N/A
N/A	Landing X Slope (%)	N/A	N/A	DWS Full Width?	N/A
N/A	Landing Curb? (Y/N)	N/A	N/A	DWS Offset (in)	N/A
N/A	Shared Landing?	N/A			
N/A	Gutter Ponding?	N/A	N/A	Gutter Slope (%)	N/A
N/A	Gutter Lip Ht (in)	N/A	N/A	Gutter X Slope (%)	N/A
N/A	Painted X Walk1?	No	N/A	Painted X Walk2?	No
	X Walk 1 Direction	To NE		X Walk 2 Direction	To NW
N/A	X Walk 1 Width (in)	N/A	N/A	X Walk 2 Width (in)	N/A
	X Walk 1 Slope (%)	2.1		X Walk 2 Slope (%)	1.0
	X Walk 1 X Slope (%)	0.7		X Walk 2 X Slope (%)	0.7

N/A	Ramp inside XWalk1?	N/A	N/A	Ramp inside XWalk2?	N/A
	Road Slope (%)	1.7	N/A	Clear Space?	N/A
	Road X Slope (%)	3.4	N/A	Clear Space to XWalk (in)	N/A
N/A	Any Obstructions?	N/A	N/A	Storm Grate/Utility Hazard?	N/A
	Obstruction Type			Storm Grate/Utility Type	
		N/A			N/A
		Yes		Surface Condition? (G/P)	Good

Remove & Replace Curb Ramp With Two New Directional Ramps or Equivalent.

Total Cost: \$ 3200.00
