# Access Compliance Report

## Public Rights-of-Way

### (Curb Ramps)

Intersection ID: 29294	Main Street: LOOKING_GLASS_LN	Cross Street: FAR_WEST_DR	Location: SE
ADA ID: E9F003D802D8	Ramp Type: PerpDiag	Initial Pass/Fail: Fail	Overall Compliance: No
Severity Score: 22.5			
Codes/Mitigation Info/Possible Solution		Field Measurements/Component Compliance

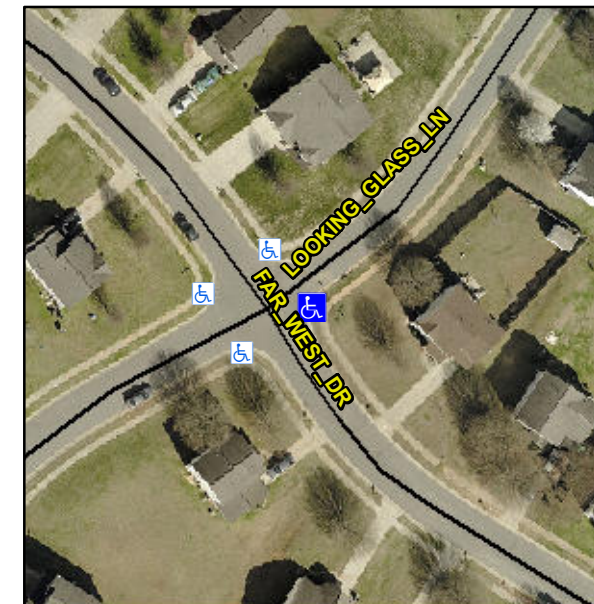
Compliance	Description	Data	Compliance	Description	Data
N/A	Ramp Length (in)	55.0	No	Ramp Slope (%)	11.1
No	Ramp Width (in)	41.5	No	Ramp XSlope (%)	2.1
N/A	Flare Type LT	N/A	N/A	Flare Type RT	N/A
N/A	Flare Slope LT (%)	N/A	N/A	Flare Slope RT (%)	N/A
N/A	Flare Traversable LT?	N/A	N/A	Flare Traversable RT?	N/A
N/A	Landing Length (in)	N/A	N/A	DWS Provided?	N/A
N/A	Landing Width (in)	N/A	N/A	DWS Contrast?	N/A
N/A	Landing Slope (%)	N/A	N/A	DWS Length (in)	N/A
N/A	Landing X Slope (%)	N/A	N/A	DWS Full Width?	N/A
N/A	Landing Curb? (Y/N)	N/A	N/A	DWS Offset (in)	N/A
N/A	Shared Landing?	N/A			
N/A	Gutter Ponding?	N/A	N/A	Gutter Slope (%)	N/A
N/A	Gutter Lip Ht (in)	N/A	N/A	Gutter X Slope (%)	N/A
N/A	Painted X Walk1?	No	N/A	Painted X Walk2?	No
	X Walk 1 Direction	To N		X Walk 2 Direction	To W
N/A	X Walk 1 Width (in)	N/A	N/A	X Walk 2 Width (in)	N/A
	X Walk 1 Slope (%)	3.2		X Walk 2 Slope (%)	0.2
	X Walk 1 X Slope (%)	0.1		X Walk 2 X Slope (%)	3.2

N/A	Ramp inside XWalk1?	N/A	N/A	Ramp inside XWalk2?	N/A
	Road Slope (%)	1.4	N/A	Clear Space?	N/A
	Road X Slope (%)	2.8	N/A	Clear Space to XWalk (in)	N/A
N/A	Any Obstructions?	N/A	N/A	Storm Grate/Utility Hazard?	N/A
	Obstruction Type			Storm Grate/Utility Type	
		N/A			N/A
			Yes	Surface Condition? (G/P)	Good

**Remove & Replace Curb Ramp With Two New Directional Ramps or Equivalent.**

**R304.5.1, R304.2.2, R304.5.3**
