Access Compliance Report

Public Rights-of-Way

(Curb Ramps)

Intersection ID: 11289	Main Street: E_18TH_ST	Cross Street: PARKWOOD_AV	Location: S
ADA ID: E9FDBE711CDC	Ramp Type: Directional1	Initial Pass/Fail: Fail	Overall Compliance: No
		Severity Score: 13.75

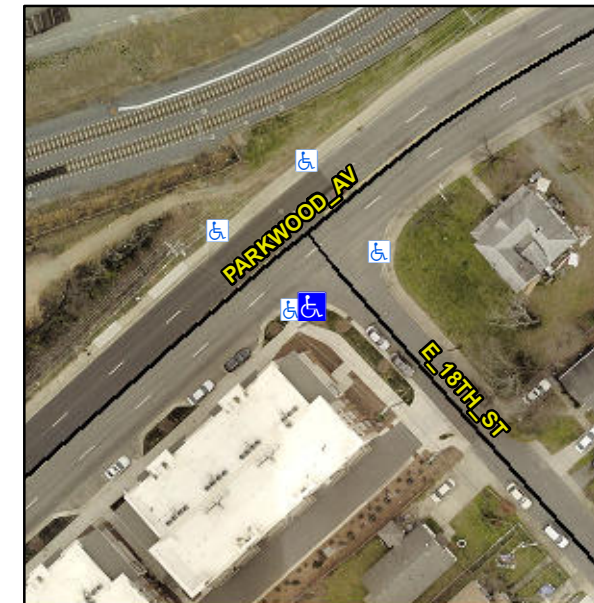
R304.2.2, R304.5.3

Compliance	Description	Data	Compliance	Description	Data
N/A	Ramp Length (in)	53.0	N/A	Grade Break?	N/A
Yes	Ramp Width (in)	68.0	N/A	Grade Break Slope (%)	0.0
No	Ramp Slope (%)	8.7	N/A	Grade Break XSlope (%)	0.0
No	Ramp XSlope (%)	3.2			
N/A	Flare Type LT	N/A	N/A	Flare Type RT	N/A
N/A	Flare Slope LT (%)	N/A	N/A	Flare Slope RT (%)	0.0
N/A	Flare Traversable LT?	N/A	N/A	Flare Traversable RT?	N/A
N/A	Landing Length (in)	0.0	N/A	DWS Provided?	N/A
N/A	Landing Width (in)	0.0	N/A	DWS Contrast?	N/A
N/A	Landing Slope (%)	0.0	N/A	DWS Length (in)	N/A
N/A	Landing X Slope (%)	0.0	N/A	DWS Full Width?	N/A
N/A	Landing Curb? (Y/N)	N/A	N/A	DWS Offset LT (in)	N/A
N/A	Shared Landing?	N/A	N/A	DWS Offset RT (in)	N/A
N/A	Gutter Ponding?	0.0	N/A	Gutter Slope (%)	N/A
N/A	Gutter Lip Ht (in)	0.0	N/A	Gutter X Slope (%)	N/A
N/A	Painted X Walk1?	No		Road Slope (%)	0.5
	X Walk 1 Direction	To NE		Road X Slope (%)	0.5
	X Walk 1 Width (in)	N/A		Clear Space?	N/A

X Walk 1 Slope (%)	0.5	N/A	Clear Space to XWalk (in)	N/A
	X Walk 1 X Slope (%)	0.5	N/A	Storm Grate/Utility Hazard?	N/A
N/A	Ramp inside XWalk1?	N/A		Storm Grate/Utility Type	
N/A	Any Obstructions?	N/A			N/A
	Obstruction Type		Yes	Surface Condition? (G/P)	Good
			N/A	Curb Slope (%)	15.7

Remove & Replace Entire Ramp.
