Access Compliance Report

Public Rights-of-Way

(Curb Ramps)

Intersection ID: 30461	Main Street: STEELE_CREEK_RD	Cross Street: STEELE_MEADOW_RD	Location: SW
ADA ID: EA0CDBC245C4	Ramp Type: Directional1	Initial Pass/Fail: Fail	Overall Compliance: No
		Severity Score: 12.5

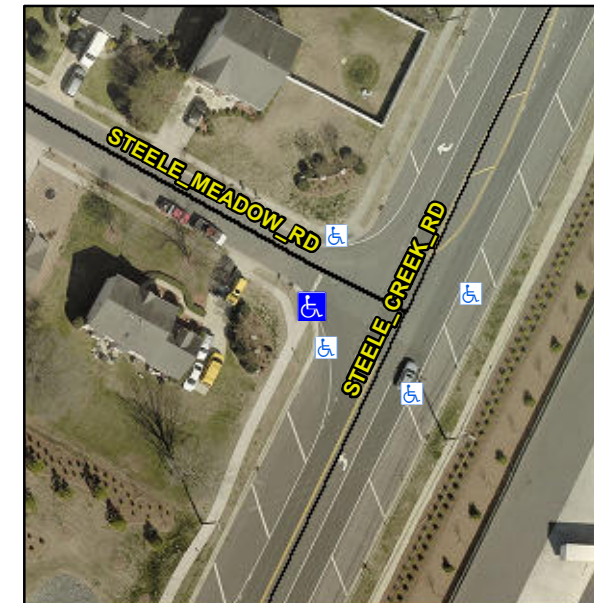
Compliance	Description	Data	Compliance	Description	Data
N/A	Ramp Length (in)	91.0	N/A	Grade Break?	N/A
Yes	Ramp Width (in)	59.0	N/A	Grade Break Slope (%)	0.0
No	Ramp Slope (%)	8.6	N/A	Grade Break XSlope (%)	0.0
Yes	Ramp XSlope (%)	0.9			
N/A	Flare Type LT	N/A	N/A	Flare Type RT	N/A
N/A	Flare Slope LT (%)	N/A	N/A	Flare Slope RT (%)	0.0
N/A	Flare Traversable LT?	N/A	N/A	Flare Traversable RT?	N/A
N/A	Landing Length (in)	0.0	N/A	DWS Provided?	N/A
N/A	Landing Width (in)	0.0	N/A	DWS Contrast?	N/A
N/A	Landing Slope (%)	0.0	N/A	DWS Length (in)	N/A
N/A	Landing X Slope (%)	0.0	N/A	DWS Full Width?	N/A
N/A	Landing Curb? (Y/N)	N/A	N/A	DWS Offset LT (in)	N/A
N/A	Shared Landing?	N/A	N/A	DWS Offset RT (in)	N/A
N/A	Gutter Ponding?	0.0	N/A	Gutter Slope (%)	N/A
N/A	Gutter Lip Ht (in)	0.0	N/A	Gutter X Slope (%)	N/A
N/A	Painted X Walk1?	No		Road Slope (%)	1.9
	X Walk 1 Direction	To N		Road X Slope (%)	0.8
	X Walk 1 Width (in)	N/A		Clear Space?	N/A

X Walk 1 Slope (%)	1.9	N/A	Clear Space to XWalk (in)	N/A
	X Walk 1 X Slope (%)	0.8	N/A	Storm Grate/Utility Hazard?	N/A
N/A	Ramp inside XWalk1?	N/A		Storm Grate/Utility Type	
N/A	Any Obstructions?	N/A			N/A
	Obstruction Type		Yes	Surface Condition? (G/P)	Good
			N/A	Curb Slope (%)	9.5

Possible Solutions:

Remove & Replace Entire Ramp.
