Access Compliance Report

Public Rights-of-Way

(Curb Ramps)

Intersection ID: N/A	Main Street: AGNEW_DR	Cross Street: PAMPLIN_CT	Location: NE
ADA ID: EA123BAB9E07	Ramp Type: BlendTrans1	Initial Pass/Fail: Fail	Overall Compliance: No
		Severity Score: 8.75

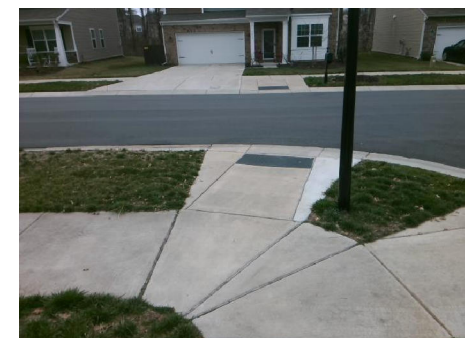
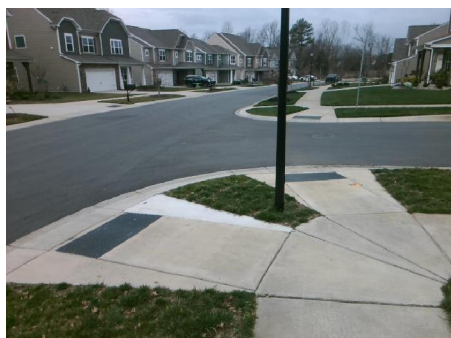
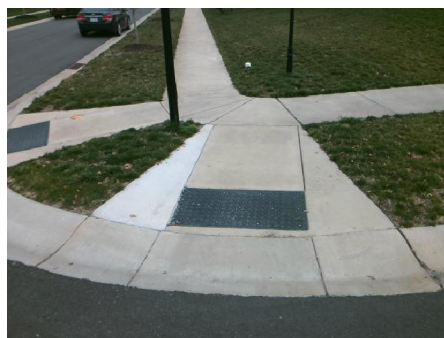
Not Found, R304.5.1

Compliance	Description	Data	Compliance	Description	Data
N/A	Ramp Length (in)	98.0	Yes	BlendTrans Slope (%)	4.6
No	Ramp Width (in)	46.5	Yes	BlendTrans XSlope (%)	1.4
N/A	Flare Type LT	N/A	N/A	Flare Type RT	N/A
N/A	Flare Slope LT (%)	N/A	N/A	Flare Slope RT (%)	N/A
N/A	Flare Traversable LT?	N/A	N/A	Flare Traversable RT?	N/A
N/A	Landing Length (in)	N/A	N/A	DWS Provided?	N/A
N/A	Landing Width (in)	N/A	N/A	DWS Contrast?	N/A
N/A	Landing Slope (%)	N/A	N/A	DWS Length (in)	N/A
N/A	Landing X Slope (%)	N/A	N/A	DWS Full Width?	N/A
N/A	Landing Curb? (Y/N)	N/A	N/A	DWS Offset (in)	N/A
N/A	Shared Landing?	N/A			
N/A	Gutter Ponding?	N/A	N/A	Gutter Slope (%)	N/A
N/A	Gutter Lip Ht (in)	N/A	N/A	Gutter X Slope (%)	N/A
N/A	Painted X Walk1?	No	N/A	Painted X Walk2?	N/A
	X Walk 1 Direction	To SW		X Walk 2 Direction	N/A
	X Walk 1 Width (in)	N/A		X Walk 2 Width (in)	N/A
	X Walk 1 Slope (%)	2.1		X Walk 2 Slope (%)	N/A
	X Walk 1 X Slope (%)	0.8		X Walk 2 X Slope (%)	N/A

N/A	Ramp inside XWalk1?	N/A	N/A	Ramp inside XWalk2?	N/A
	Road Slope (%)	0.8		Clear Space?	N/A
	Road X Slope (%)	2.1	N/A	Clear Space to XWalk (in)	N/A
N/A	Any Obstructions?	N/A	N/A	Storm Grate/Utility Hazard?	N/A
	Obstruction Type			Storm Grate/Utility Type	
		N/A			N/A
			Yes	Surface Condition? (G/P)	Good
			No	Curb Slope (%)	8.2

Remove & Replace Curb Ramp With Two New Directional Ramps or Equivalent.
