Access Compliance Report

Public Rights-of-Way

(Curb Ramps)

Intersection ID: 9858	Main Street: MERCURY_ST	Cross Street: N_DAVIDSON_ST	Location:	N
ADA ID: EA1415D70F91	Ramp Type: BlendTrans2	Initial Pass/Fail: Pass	Overall Compliance: No	Severity Score: 0

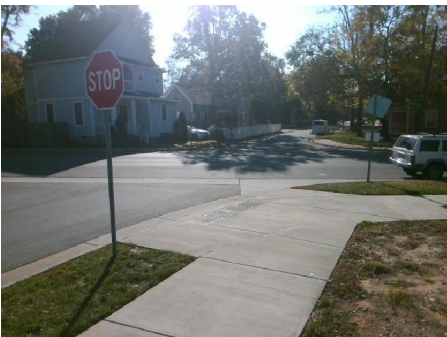
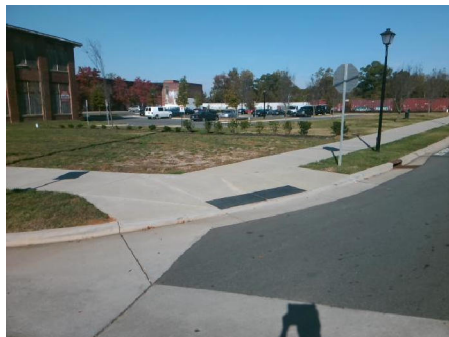
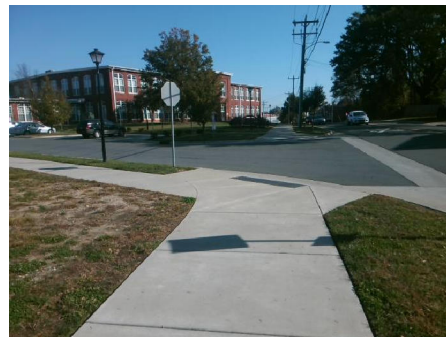
Compliance	Description	Data	Compliance	Description	Data
N/A	Ramp Length (in)	125.0	Yes	BlendTrans Slope (%)	4.6
Yes	Ramp Width (in)	96.0	Yes	BlendTrans XSlope (%)	1.6
N/A	Flare Type LT	Sloped	N/A	Flare Type RT	Sloped
N/A	Flare Slope LT (%)	N/A	No	Flare Slope RT (%)	N/A
N/A	Flare Traversable LT?	No	N/A	Flare Traversable RT?	Yes
N/A	Landing Length (in)	N/A	Yes	DWS Provided?	Yes
N/A	Landing Width (in)	N/A	Yes	DWS Contrast?	Yes
N/A	Landing Slope (%)	N/A	Yes	DWS Length (in)	24.0
N/A	Landing X Slope (%)	N/A	Yes	DWS Full Width?	Yes
N/A	Landing Curb? (Y/N)	No	No	DWS Offset (in)	2.5
N/A	Shared Landing?	No			
Yes	Gutter Ponding?	No	Yes	Gutter Slope (%)	0.5
Yes	Gutter Lip Ht (in)	0.0	Yes	Gutter X Slope (%)	1.5
N/A	Painted X Walk1?	No	N/A	Painted X Walk2?	N/A
	X Walk 1 Direction	To NE		X Walk 2 Direction	N/A
	X Walk 1 Width (in)	N/A		X Walk 2 Width (in)	N/A
	X Walk 1 Slope (%)	3.0		X Walk 2 Slope (%)	N/A
	X Walk 1 X Slope (%)	1.4		X Walk 2 X Slope (%)	N/A

N/A	Ramp inside XWalk1?	N/A	N/A	Ramp inside XWalk2?	N/A
	Road Slope (%)	1.4		Clear Space?	Yes
	Road X Slope (%)	3.0	N/A	Clear Space to XWalk (in)	N/A
Yes	Any Obstructions?	No	Yes	Storm Grate/Utility Hazard?	No
	Obstruction Type			Storm Grate/Utility Type	
		N/A			N/A
			Yes	Surface Condition? (G/P)	Good
			Yes	Curb Slope (%)	4.5

Possible Solutions:

Remove & Replace Curb Ramp With Two New Directional Ramps or Equivalent.
