Access Compliance Report

Public Rights-of-Way

(Curb Ramps)

Intersection ID: 48492	Main Street: SHOPTON_RD_WEST	Cross Street: BEREWICK_COMMONS_PY	Location: NE
ADA ID: EA23448D7F89	Ramp Type: Perp	Initial Pass/Fail: Fail	Overall Compliance: No
Severity Score: 8.75			
Codes/Mitigation Info/Possible Solution		Field Measurements/Component Compliance

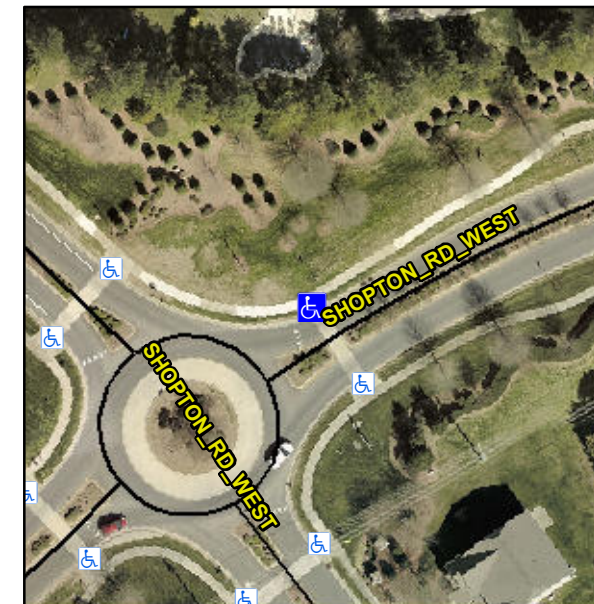
Not Found, R304.5.1

Compliance	Description	Data	Compliance	Description	Data
N/A	Ramp Length (in)	47.0	Yes	Ramp Slope (%)	6.3
No	Ramp Width (in)	46.5	Yes	Ramp XSlope (%)	1.8
N/A	Flare Type LT	N/A	N/A	Flare Type RT	N/A
N/A	Flare Slope LT (%)	N/A	N/A	Flare Slope RT (%)	N/A
N/A	Flare Traversable LT?	N/A	N/A	Flare Traversable RT?	N/A
N/A	Landing Length (in)	N/A	N/A	DWS Provided?	N/A
N/A	Landing Width (in)	N/A	N/A	DWS Contrast?	N/A
N/A	Landing Slope (%)	N/A	N/A	DWS Length (in)	N/A
N/A	Landing X Slope (%)	N/A	N/A	DWS Full Width?	N/A
N/A	Landing Curb? (Y/N)	N/A	N/A	DWS Offset (in)	N/A
N/A	Shared Landing?	N/A			
N/A	Gutter Ponding?	N/A	N/A	Gutter Slope (%)	N/A
N/A	Gutter Lip Ht (in)	N/A	N/A	Gutter X Slope (%)	N/A
N/A	Painted X Walk1?	Yes	N/A	Painted X Walk2?	N/A
	X Walk 1 Direction	To SE		X Walk 2 Direction	N/A
N/A	X Walk 1 Width (in)	94.0	N/A	X Walk 2 Width (in)	N/A
	X Walk 1 Slope (%)	1.7		X Walk 2 Slope (%)	N/A
	X Walk 1 X Slope (%)	1.7		X Walk 2 X Slope (%)	N/A

N/A	Ramp inside XWalk1?	Yes	N/A	Ramp inside XWalk2?	N/A
	Road Slope (%)	N/A	N/A	Clear Space?	N/A
	Road X Slope (%)	N/A	N/A	Clear Space to XWalk (in)	N/A
N/A	Any Obstructions?	N/A	N/A	Storm Grate/Utility Hazard?	N/A
	Obstruction Type			Storm Grate/Utility Type	
		N/A			N/A
			Yes	Surface Condition? (G/P)	Good

Possible Solutions:

Remove & Replace Entire Ramp.
