Access Compliance Report Public Rights-of-Way (Curb Ramps)

Intersection ID: 50597 Main S	Main Street: DOWNY_BIRCH_RD		Cross Street: GRAY_WILLOW_RD				SE	
ADA ID: EA252DDD7352 Ramp	Ramp Type: Perp		Initial Pass/Fail: Fail Overall Compliance: N			o Severity Score:	10	
Codes/Mitigation Info/Possible Solution		Field Measurements/Component Compliance						
	Possible Solutions:	Com	Compliance Description Data			Compliance Description Data		
	Remove & Replace Entire Ramp	. N/A	Ramp Length (in)	48.5	Yes	Ramp Slope (%)	7.5	
		No	Ramp Width (in)	46.5	No	Ramp XSlope (%)	3.2	
		N/A	Flare Type LT	N/A	N/A	Flare Type RT	N/A	
		N/A	Flare Slope LT (%)	N/A	N/A	Flare Slope RT (%)	N/A	
E WILLOW LE	-	N/A	Flare Traversable LT?	N/A	N/A	Flare Traversable RT?	N/A	
E B GRAV		N/A	Landing Length (in)	N/A	N/A	DWS Provided?	N/A	
	Surveyor Notes:	N/A	Landing Width (in)	N/A	N/A	DWS Contrast?	N/A	
	N/A	N/A	Landing Slope (%)	N/A	N/A	DWS Length (in)	N/A	
		N/A	Landing X Slope (%)	N/A	N/A	DWS Full Width?	N/A

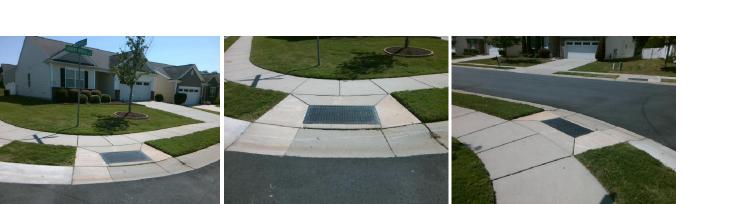
N/A	Landing Curb? (Y/N)	N/A	N/A	DWS Offset (in)	N/A	
E - I - E		N/A	Shared Landing?	N/A				
	PROW/ADA:	N/A	Gutter Ponding?	N/A	N/A	Gutter Slope (%)	N/A	
	Not Found, R304.5.1, R304.5.3	N/A	Gutter Lip Ht (in)	N/A	N/A	Gutter X Slope (%)	N/A	
		N/A	Painted X Walk1?	No	N/A	Painted X Walk2?	N/A	
			X Walk 1 Direction	To W		X Walk 2 Direction	N/A	
		N/A	X Walk 1 Width (in)	N/A	N/A	X Walk 2 Width (in)	N/A	
Street 1 Name DOWNY BIRCH RE)		X Walk 1 Slope (%)	1.2		X Walk 2 Slope (%)	N/A	
Stop Condition-Street 2 None	9		X Walk 1 X Slope (%)	2.3		X Walk 2 X Slope (%)	N/A	
Street 2 Name N/A	N N N N N N N N N N N N N N N N N N N	N/A	Ramp inside XWalk1?	N/A	N/A	Ramp inside XWalk2?	N/A	
Stop Condition-Street 1 N/A	N N		Road Slope (%)	N/A	N/A	Clear Space?	N/A	
			Road X Slope (%)	N/A	N/A	Clear Space to XWalk (in)	N/A	
		N/A	Any Obstructions?	N/A	N/A	Storm Grate/Utility Hazard?	N/A	
	Total Cost: \$	1850.00	Obstruction Type			Storm Grate/Utility Type
