Access Compliance Report

Public Rights-of-Way

(Curb Ramps)

| Intersection ID: 14742 | Main Street: E_7TH_ST | Cross Street: E_5TH_ST | Location: SW |

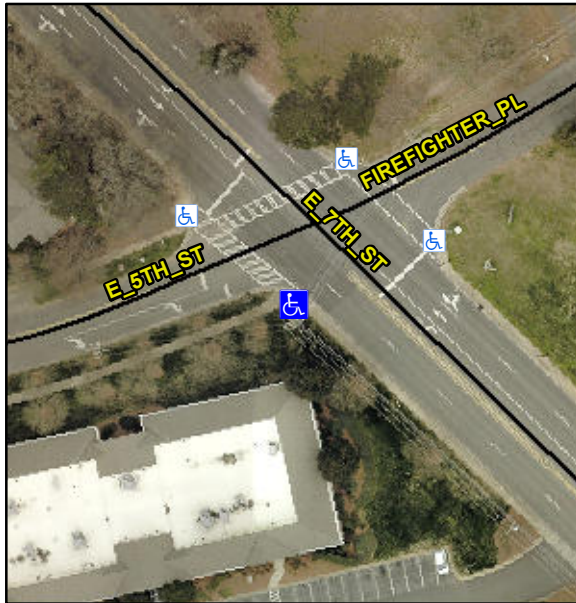
| ADA ID: EA29E21985A6 | Ramp Type: PerpDiag | Initial Pass/Fail: Fail | Overall Compliance: No |

Not Found, R304.5.1, R304.2.2, R304.5.3

| Compliance | Description | Data | Compliance | Description | Data |
|---|---|---|---|---|---|
| N/A | Ramp Length (in) | 40.0 | No | Ramp Slope (%) | 12.6 |
| No | Ramp Width (in) | 40.0 | No | Ramp XSlope (%) | 5.1 |

Remove & Replace Curb Ramp With Two New Directional Ramps or Equivalent.
