# Access Compliance Report

## Public Rights-of-Way

### (Curb Ramps)

Intersection ID: 21239	Main Street: CAMBRIDGE BELTWAY DR	Cross Street: S TRYON ST	Location: S
ADA ID: EA2B165A81AC	Ramp Type: Perp	Initial Pass/Fail: Fail	Overall Compliance: No
Severity Score: 33.75			
Codes/Mitigation Info/Possible Solution		Field Measurements/Component Compliance

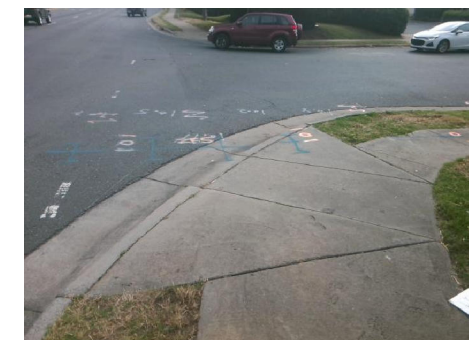
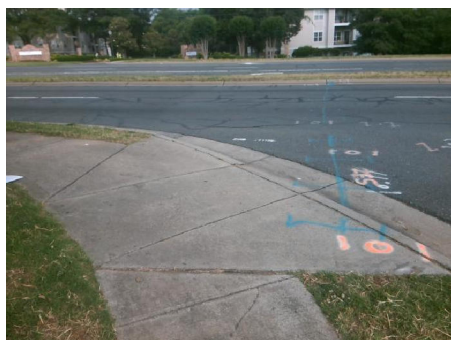
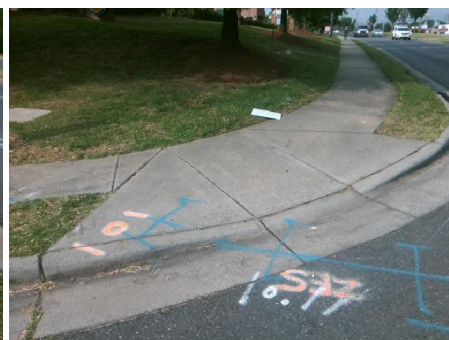
**Not Found, R304.5.1, R304.2.2, R304.5.3**

Compliance	Description	Data	Compliance	Description	Data
N/A	Ramp Length (in)	88.0	No	Ramp Slope (%)	8.5
No	Ramp Width (in)	45.0	No	Ramp XSlope (%)	6.6
N/A	Flare Type LT	N/A	N/A	Flare Type RT	N/A
N/A	Flare Slope LT (%)	N/A	N/A	Flare Slope RT (%)	N/A
N/A	Flare Traversable LT?	N/A	N/A	Flare Traversable RT?	N/A
N/A	Landing Length (in)	N/A	N/A	DWS Provided?	N/A
N/A	Landing Width (in)	N/A	N/A	DWS Contrast?	N/A
N/A	Landing Slope (%)	N/A	N/A	DWS Length (in)	N/A
N/A	Landing X Slope (%)	N/A	N/A	DWS Full Width?	N/A
N/A	Landing Curb? (Y/N)	N/A	N/A	DWS Offset (in)	N/A
N/A	Shared Landing?	N/A			
N/A	Gutter Ponding?	N/A	N/A	Gutter Slope (%)	N/A
N/A	Gutter Lip Ht (in)	N/A	N/A	Gutter X Slope (%)	N/A
N/A	Painted X Walk1?	No	N/A	Painted X Walk2?	N/A
	X Walk 1 Direction	To NE		X Walk 2 Direction	N/A
N/A	X Walk 1 Width (in)	N/A	N/A	X Walk 2 Width (in)	N/A
	X Walk 1 Slope (%)	3.6		X Walk 2 Slope (%)	N/A
	X Walk 1 X Slope (%)	2.0		X Walk 2 X Slope (%)	N/A

N/A	Ramp inside XWalk1?	N/A	N/A	Ramp inside XWalk2?	N/A
	Road Slope (%)	N/A	N/A	Clear Space?	N/A
	Road X Slope (%)	N/A	N/A	Clear Space to XWalk (in)	N/A
N/A	Any Obstructions?	N/A	N/A	Storm Grate/Utility Hazard?	N/A
	Obstruction Type			Storm Grate/Utility Type	
		N/A			N/A
			Yes	Surface Condition? (G/P)	Good

**Remove & Replace Entire Ramp.**

Total Cost: \$ 1850.00
