Access Compliance Report

Public Rights-of-Way

(Curb Ramps)

Intersection ID: 13118	Main Street: E_7TH_ST	Cross Street: CENTRAL_AV	Location: S
ADA ID: EA2C8E792AE9	Ramp Type: Para	Initial Pass/Fail: Fail	Overall Compliance: No
Severity Score: 13.75			
Codes/Mitigation Info/Possible Solution		Field Measurements/Component Compliance

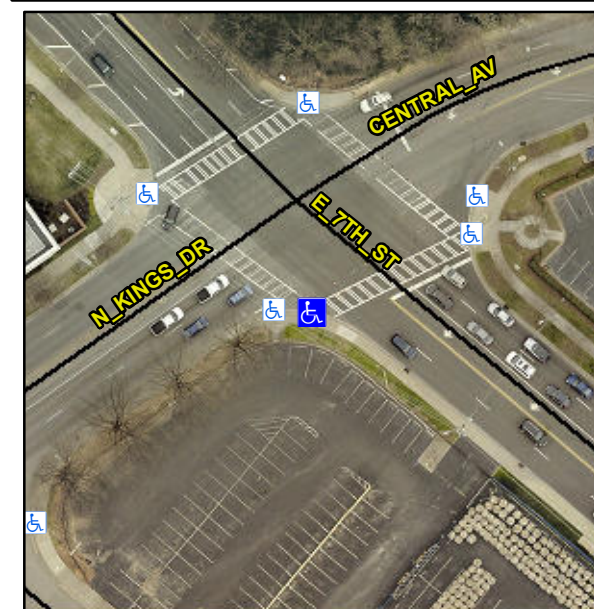
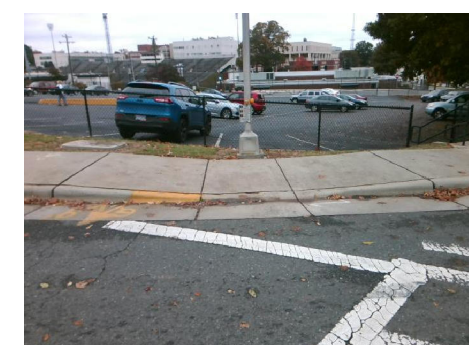
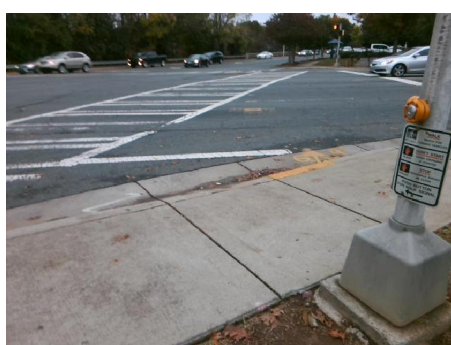
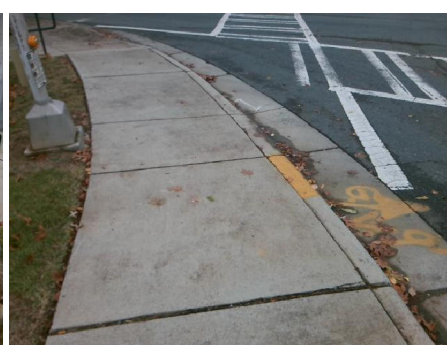
RT RP < 5%

PROW/ADA:

R304.3.2, R304.5.3

Compliance	Description	Data	Compliance	Description	Data
N/A	Ramp Length LT (in)	61.5	N/A	Ramp Length RT (in)	64.0
Yes	Ramp Width LT (in)	61.0	Yes	Ramp Width RT (in)	60.0
No	Ramp Slope LT (%)	9.8	Yes	Ramp Slope RT (%)	1.9
No	Ramp XSlope LT (%)	2.7	No	Ramp XSlope RT (%)	2.1
N/A	Landing Length (in)	N/A	N/A	DWS Provided?	N/A
N/A	Landing Width (in)	N/A	N/A	DWS Contrast?	N/A
N/A	Landing Slope (%)	N/A	N/A	DWS Length (in)	N/A
N/A	Landing X Slope (%)	N/A	N/A	DWS Full Width?	N/A
N/A	Landing Curb? (Y/N)	N/A	N/A	DWS Offset (in)	N/A
N/A	Shared Landing?	N/A			
N/A	Gutter Ponding?	N/A	N/A	Gutter Slope (%)	N/A
N/A	Gutter Lip Ht (in)	N/A	N/A	Gutter X Slope (%)	N/A
N/A	Painted X Walk1?	Yes	N/A	Painted X Walk2?	N/A
	X Walk 1 Direction	To NE		X Walk 2 Direction	N/A
N/A	X Walk 1 Width (in)	110.0	N/A	X Walk 2 Width (in)	N/A
	X Walk 1 Slope (%)	1.2		X Walk 2 Slope (%)	N/A
	X Walk 1 X Slope (%)	1.7		X Walk 2 X Slope (%)	N/A
N/A	Ramp inside XWalk1?	Yes	N/A	Ramp inside XWalk2?	N/A

Road Slope (%)	N/A	N/A	Clear Space?	N/A
	Road X Slope (%)	N/A	N/A	Clear Space to XWalk (in)	N/A
N/A	Any Obstructions?	N/A	N/A	Storm Grate/Utility Hazard?	N/A
	Obstruction Type			Storm Grate/Utility Type	
		N/A			N/A
			Yes	Surface Condition? (G/P)	Good
			N/A	Curb Slope (%)	12.5

Possible Solutions:

Remove & Replace Entire Ramp.
