Access Compliance Report

Public Rights-of-Way

(Curb Ramps)

Intersection ID: 48457	Main Street: FOX_POINT_DR	Cross Street: PANGLEMONT_DR	Location: W
ADA ID: EA3A1C61DF41	Ramp Type: PerpDiag	Initial Pass/Fail: Fail	Overall Compliance: No
Severity Score: 33.75			
Codes/Mitigation Info/Possible Solution		Field Measurements/Component Compliance

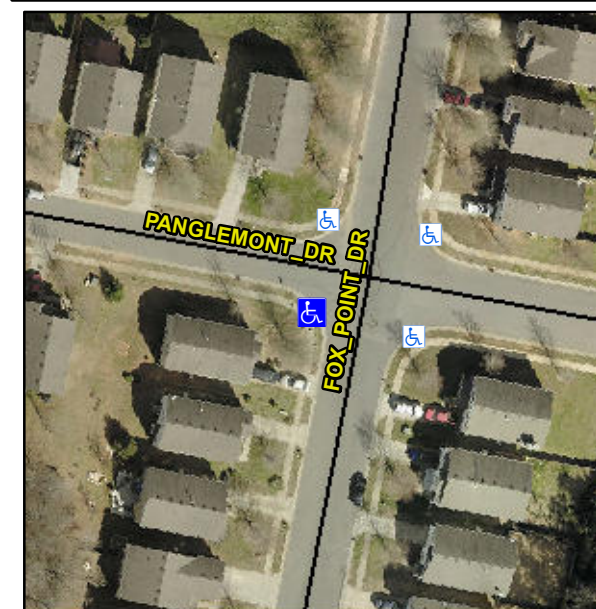
Not Found, R304.5.1, R304.5.3

Compliance	Description	Data	Compliance	Description	Data
N/A	Ramp Length (in)	47.5	Yes	Ramp Slope (%)	5.8
No	Ramp Width (in)	46.5	No	Ramp XSlope (%)	10.1
N/A	Flare Type LT	N/A	N/A	Flare Type RT	N/A
N/A	Flare Slope LT (%)	N/A	N/A	Flare Slope RT (%)	N/A
N/A	Flare Traversable LT?	N/A	N/A	Flare Traversable RT?	N/A
N/A	Landing Length (in)	N/A	N/A	DWS Provided?	N/A
N/A	Landing Width (in)	N/A	N/A	DWS Contrast?	N/A
N/A	Landing Slope (%)	N/A	N/A	DWS Length (in)	N/A
N/A	Landing X Slope (%)	N/A	N/A	DWS Full Width?	N/A
N/A	Landing Curb? (Y/N)	N/A	N/A	DWS Offset (in)	N/A
N/A	Shared Landing?	N/A			
N/A	Gutter Ponding?	N/A	N/A	Gutter Slope (%)	N/A
N/A	Gutter Lip Ht (in)	N/A	N/A	Gutter X Slope (%)	N/A
N/A	Painted X Walk1?	No	N/A	Painted X Walk2?	No
	X Walk 1 Direction	To SE		X Walk 2 Direction	To NE
N/A	X Walk 1 Width (in)	N/A	N/A	X Walk 2 Width (in)	N/A
	X Walk 1 Slope (%)	6.1		X Walk 2 Slope (%)	0.8
	X Walk 1 X Slope (%)	6.1		X Walk 2 X Slope (%)	7.5

N/A	Ramp inside XWalk1?	N/A	N/A	Ramp inside XWalk2?	N/A
	Road Slope (%)	8.3	N/A	Clear Space?	N/A
	Road X Slope (%)	3.4	N/A	Clear Space to XWalk (in)	N/A
N/A	Any Obstructions?	N/A	N/A	Storm Grate/Utility Hazard?	N/A
	Obstruction Type			Storm Grate/Utility Type	
		N/A			N/A
		Yes		Surface Condition? (G/P)	Good

Remove & Replace Curb Ramp With Two New Directional Ramps or Equivalent.

Total Cost: \$ 3200.00
