# Access Compliance Report

## Public Rights-of-Way

| Intersection ID: 10036734 | | Main Street: S DAVIDSON ST | | Cross Street: N/A | | Location: NE | | | | | |
| ADA ID: EA3C7D692ACC | | Ramp Type: Directional1 | | Initial Pass/Fail: Pass | | Overall Compliance: No | | Severity Score: 0.25 | | | |

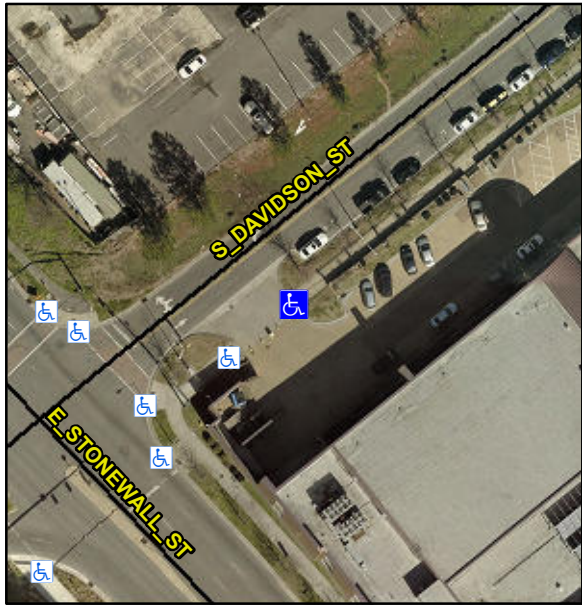
| <div>Street 1 NameS DAVIDSON ST</div> <div>Stop Condition-Street 1None</div> <div>Street 2 NameN/A</div> <div>Stop Condition-Street 2N/A</div> | | | | Possible Solutions: | | Compliance | | Description | | Data | |
| | | | | Remove & Replace Entire Ramp.<br>Remove & Replace Gutter. | | N/A | Ramp Length (in) | 98.0 | No | Grade Break? | No |
| | | Yes | Gutter Lip Ht (in) | 0.0 | No | Gutter X Slope (%) | 5.5 | | | | |
