# Access Compliance Report

## Public Rights-of-Way (Curb Ramps)

Intersection ID: 24329	Main Street: GARBOW_CT	Cross Street: MIROW_PL	Location:	N
ADA ID: EA50E55E3DEC	Ramp Type: Perp	Initial Pass/Fail: Fail	Overall Compliance: No	Severity Score: 12.5

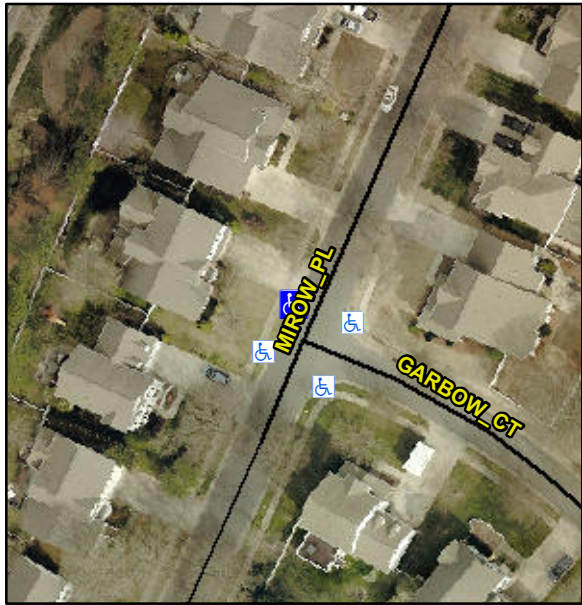
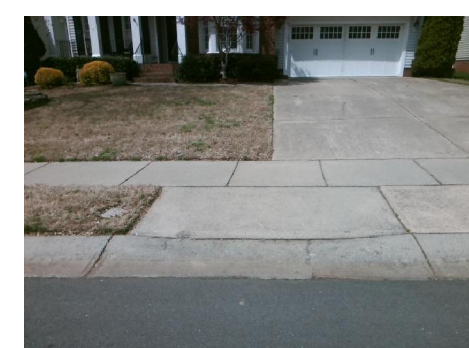
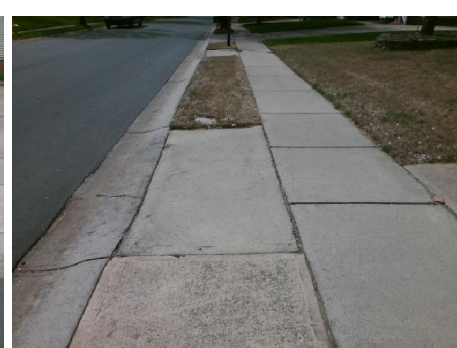
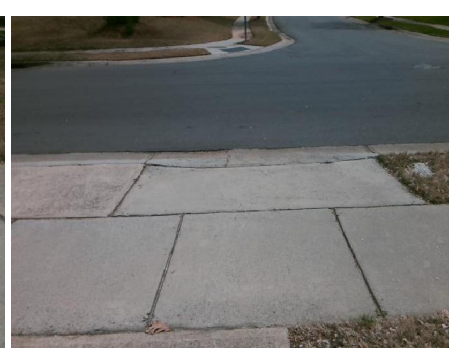
Possible Solutions:		Compliance	Description	Data	Compliance	Description	Data
	Remove & Replace Entire Ramp.		N/A	Ramp Length (in)	48.0	No	Ramp Slope (%)	9.3
			Yes	Ramp Width (in)	48.0	Yes	Ramp XSlope (%)	0.2
			N/A	Flare Type LT	N/A	N/A	Flare Type RT	N/A
			N/A	Flare Slope LT (%)	N/A	N/A	Flare Slope RT (%)	N/A
			N/A	Flare Traversable LT?	N/A	N/A	Flare Traversable RT?	N/A
			N/A	Landing Length (in)	N/A	N/A	DWS Provided?	N/A
			N/A	Landing Width (in)	N/A	N/A	DWS Contrast?	N/A
			N/A	Landing Slope (%)	N/A	N/A	DWS Length (in)	N/A
			N/A	Landing X Slope (%)	N/A	N/A	DWS Full Width?	N/A
Surveyor Notes:			N/A	Landing Curb? (Y/N)	N/A	N/A	DWS Offset (in)	N/A
N/A			N/A	Shared Landing?	N/A			
PROW/ADA:			N/A	Gutter Ponding?	N/A	N/A	Gutter Slope (%)	N/A
Not Found, R304.2.2			N/A	Gutter Lip Ht (in)	N/A	N/A	Gutter X Slope (%)	N/A

N/A	Painted X Walk1?	No	N/A	Painted X Walk2?	N/A
				X Walk 1 Direction	To SE		X Walk 2 Direction	N/A
			N/A	X Walk 1 Width (in)	N/A	N/A	X Walk 2 Width (in)	N/A
				X Walk 1 Slope (%)	4.2		X Walk 2 Slope (%)	N/A
				X Walk 1 X Slope (%)	2.5		X Walk 2 X Slope (%)	N/A
			N/A	Ramp inside XWalk1?	N/A	N/A	Ramp inside XWalk2?	N/A
				Road Slope (%)	N/A	N/A	Clear Space?	N/A
				Road X Slope (%)	N/A	N/A	Clear Space to XWalk (in)	N/A
			N/A	Any Obstructions?	N/A	N/A	Storm Grate/Utility Hazard?	N/A
				Obstruction Type			Storm Grate/Utility Type	
					N/A			N/A
						Yes	Surface Condition? (G/P)	Good
