Access Compliance Report

Public Rights-of-Way

(Curb Ramps)

Intersection ID: 14212	Main Street: HAWKINS_ST	Cross Street: W_TREMONT_AV	Location: SE
ADA ID: EA531E39875B	Ramp Type: Perp	Initial Pass/Fail: Fail	Overall Compliance: No
Severity Score: 21.25			
Codes/Mitigation Info/Possible Solution		Field Measurements/Component Compliance

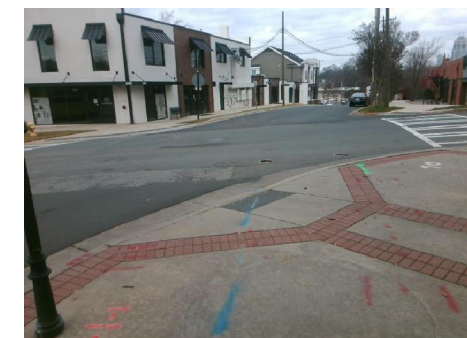
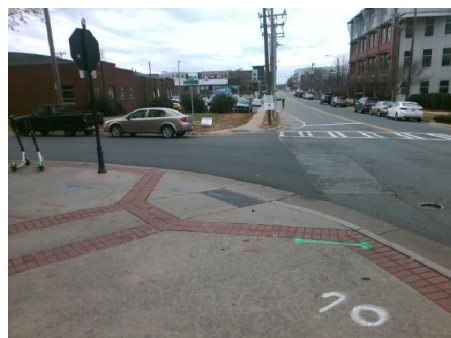
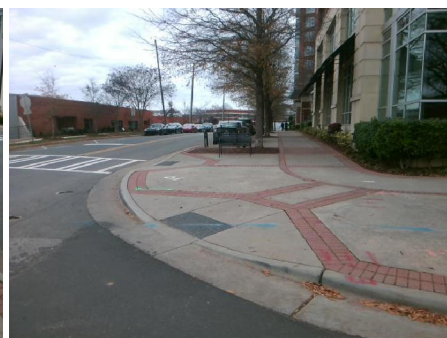
R304.5.1, R304.2.2

Compliance	Description	Data	Compliance	Description	Data
N/A	Ramp Length (in)	65.0	No	Ramp Slope (%)	8.7
No	Ramp Width (in)	47.0	Yes	Ramp XSlope (%)	0.1
N/A	Flare Type LT	N/A	N/A	Flare Type RT	N/A
N/A	Flare Slope LT (%)	N/A	N/A	Flare Slope RT (%)	N/A
N/A	Flare Traversable LT?	N/A	N/A	Flare Traversable RT?	N/A
N/A	Landing Length (in)	N/A	N/A	DWS Provided?	N/A
N/A	Landing Width (in)	N/A	N/A	DWS Contrast?	N/A
N/A	Landing Slope (%)	N/A	N/A	DWS Length (in)	N/A
N/A	Landing X Slope (%)	N/A	N/A	DWS Full Width?	N/A
N/A	Landing Curb? (Y/N)	N/A	N/A	DWS Offset (in)	N/A
N/A	Shared Landing?	N/A			
N/A	Gutter Ponding?	N/A	N/A	Gutter Slope (%)	N/A
N/A	Gutter Lip Ht (in)	N/A	N/A	Gutter X Slope (%)	N/A
N/A	Painted X Walk1?	No	N/A	Painted X Walk2?	N/A
	X Walk 1 Direction	To W		X Walk 2 Direction	N/A
N/A	X Walk 1 Width (in)	N/A	N/A	X Walk 2 Width (in)	N/A
	X Walk 1 Slope (%)	5.3		X Walk 2 Slope (%)	N/A
	X Walk 1 X Slope (%)	0.8		X Walk 2 X Slope (%)	N/A

N/A	Ramp inside XWalk1?	N/A	N/A	Ramp inside XWalk2?	N/A
	Road Slope (%)	N/A	N/A	Clear Space?	N/A
	Road X Slope (%)	N/A	N/A	Clear Space to XWalk (in)	N/A
N/A	Any Obstructions?	N/A	N/A	Storm Grate/Utility Hazard?	N/A
	Obstruction Type			Storm Grate/Utility Type	
		N/A			N/A
			Yes	Surface Condition? (G/P)	Good

Remove & Replace Entire Ramp.

Total Cost: \$ 1850.00
