Access Compliance Report

Public Rights-of-Way

(Curb Ramps)

Intersection ID: 43079	Main Street: SUMTER_AV	Cross Street: WALNUT_AV	Location: S
ADA ID: EA5663DACFD9	Ramp Type: PerpDiag	Initial Pass/Fail: Fail	Overall Compliance: No
		Severity Score: 47.5

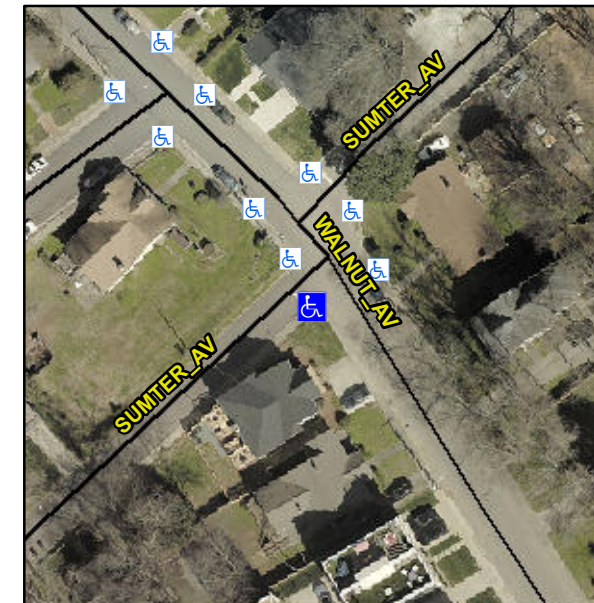
Not Found, R304.5.1, R304.2.2

Compliance	Description	Data	Compliance	Description	Data
N/A	Ramp Length (in)	52.0	No	Ramp Slope (%)	10.7
No	Ramp Width (in)	31.0	Yes	Ramp XSlope (%)	2.0
N/A	Flare Type LT	N/A	N/A	Flare Type RT	N/A
N/A	Flare Slope LT (%)	N/A	N/A	Flare Slope RT (%)	N/A
N/A	Flare Traversable LT?	N/A	N/A	Flare Traversable RT?	N/A
N/A	Landing Length (in)	N/A	N/A	DWS Provided?	N/A
N/A	Landing Width (in)	N/A	N/A	DWS Contrast?	N/A
N/A	Landing Slope (%)	N/A	N/A	DWS Length (in)	N/A
N/A	Landing X Slope (%)	N/A	N/A	DWS Full Width?	N/A
N/A	Landing Curb? (Y/N)	N/A	N/A	DWS Offset (in)	N/A
N/A	Shared Landing?	N/A			
N/A	Gutter Ponding?	N/A	N/A	Gutter Slope (%)	N/A
N/A	Gutter Lip Ht (in)	N/A	N/A	Gutter X Slope (%)	N/A
N/A	Painted X Walk1?	No	N/A	Painted X Walk2?	No
	X Walk 1 Direction	To E		X Walk 2 Direction	To N
N/A	X Walk 1 Width (in)	N/A	N/A	X Walk 2 Width (in)	N/A
	X Walk 1 Slope (%)	5.2		X Walk 2 Slope (%)	7.6
	X Walk 1 X Slope (%)	2.1		X Walk 2 X Slope (%)	6.4

N/A	Ramp inside XWalk1?	N/A	N/A	Ramp inside XWalk2?	N/A
	Road Slope (%)	1.6	N/A	Clear Space?	N/A
	Road X Slope (%)	11.3	N/A	Clear Space to XWalk (in)	N/A
N/A	Any Obstructions?	N/A	N/A	Storm Grate/Utility Hazard?	N/A
	Obstruction Type			Storm Grate/Utility Type	
		N/A			N/A
			Yes	Surface Condition? (G/P)	Good

Remove & Replace Curb Ramp With Two New Directional Ramps or Equivalent.

Total Cost: \$ 3200.00
