Access Compliance Report

Public Rights-of-Way

(Curb Ramps)

Intersection ID: 12266	Main Street: MORRIS_FIELD_DR	Cross Street: WILKINSON_BV	Location: SE
ADA ID: EA5945D1213A	Ramp Type: Perp	Initial Pass/Fail: Fail	Overall Compliance: No
Severity Score: 8.75			
Codes/Mitigation Info/Possible Solution		Field Measurements/Component Compliance

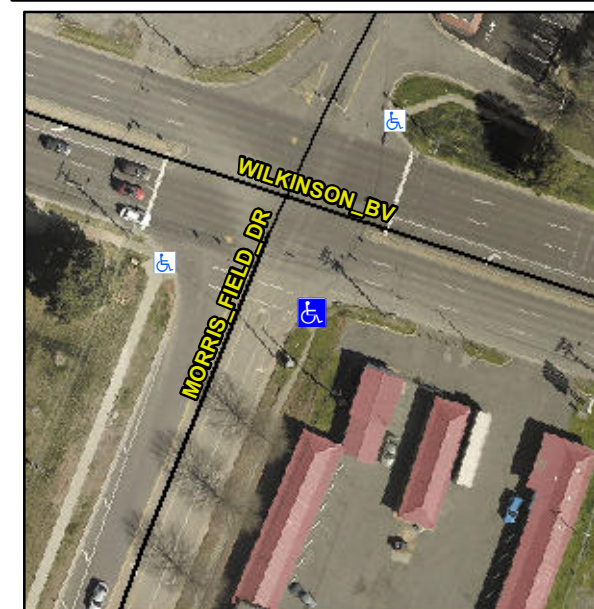
Not Found, R304.5.1

Compliance	Description	Data	Compliance	Description	Data
N/A	Ramp Length (in)	60.0	Yes	Ramp Slope (%)	7.0
No	Ramp Width (in)	47.0	Yes	Ramp XSlope (%)	1.4
N/A	Flare Type LT	N/A	N/A	Flare Type RT	N/A
N/A	Flare Slope LT (%)	N/A	N/A	Flare Slope RT (%)	N/A
N/A	Flare Traversable LT?	N/A	N/A	Flare Traversable RT?	N/A
N/A	Landing Length (in)	N/A	N/A	DWS Provided?	N/A
N/A	Landing Width (in)	N/A	N/A	DWS Contrast?	N/A
N/A	Landing Slope (%)	N/A	N/A	DWS Length (in)	N/A
N/A	Landing X Slope (%)	N/A	N/A	DWS Full Width?	N/A
N/A	Landing Curb? (Y/N)	N/A	N/A	DWS Offset (in)	N/A
N/A	Shared Landing?	N/A			
N/A	Gutter Ponding?	N/A	N/A	Gutter Slope (%)	N/A
N/A	Gutter Lip Ht (in)	N/A	N/A	Gutter X Slope (%)	N/A
N/A	Painted X Walk1?	Yes	N/A	Painted X Walk2?	N/A
	X Walk 1 Direction	To NW		X Walk 2 Direction	N/A
N/A	X Walk 1 Width (in)	110.0	N/A	X Walk 2 Width (in)	N/A
	X Walk 1 Slope (%)	0.2		X Walk 2 Slope (%)	N/A
	X Walk 1 X Slope (%)	1.6		X Walk 2 X Slope (%)	N/A

N/A	Ramp inside XWalk1?	Yes	N/A	Ramp inside XWalk2?	N/A
	Road Slope (%)	N/A	N/A	Clear Space?	N/A
	Road X Slope (%)	N/A	N/A	Clear Space to XWalk (in)	N/A
N/A	Any Obstructions?	N/A	N/A	Storm Grate/Utility Hazard?	N/A
	Obstruction Type			Storm Grate/Utility Type	
		N/A			N/A
		Yes		Surface Condition? (G/P)	Good

Remove & Replace Entire Ramp.
