Access Compliance Report

Public Rights-of-Way

(Curb Ramps)

Intersection ID: N/A	Main Street: PAUL_BUCK_BV	Cross Street: N/A	Location: NE
ADA ID: EA5955524567	Ramp Type: MedianPerp	Initial Pass/Fail: Pass	Overall Compliance: No
Severity Score: 0			
Codes/Mitigation Info/Possible Solution		Field Measurements/Component Compliance

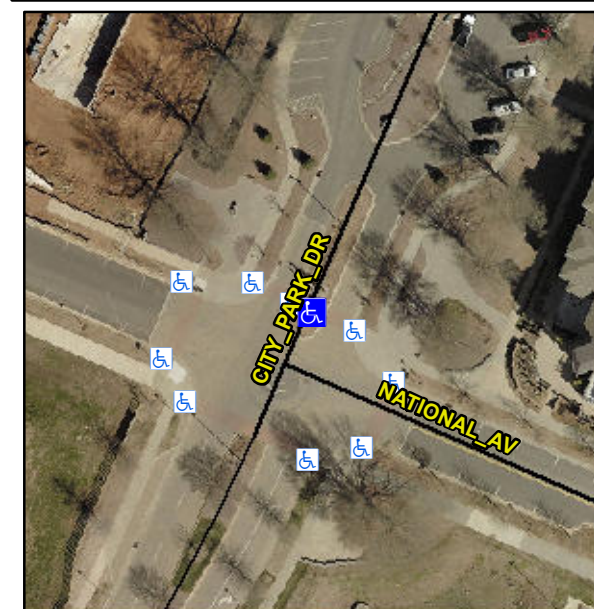
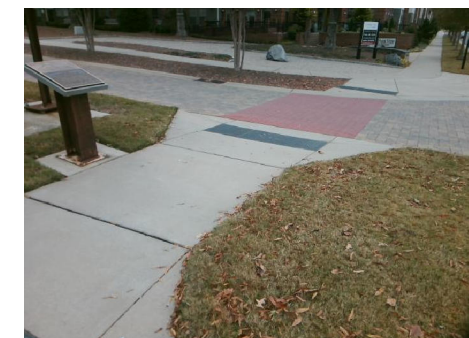
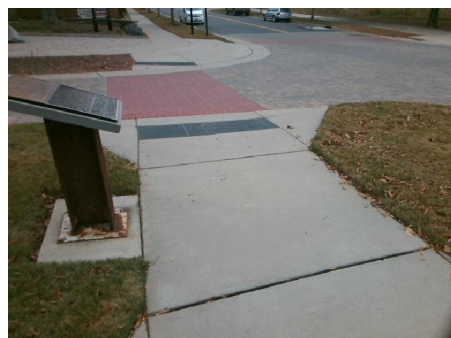
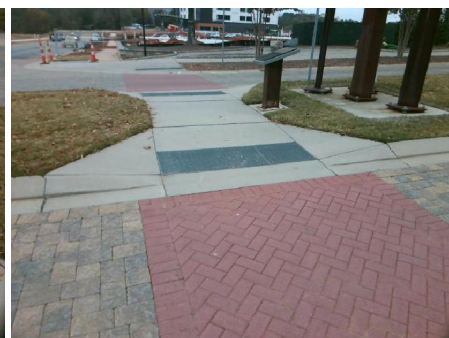
Compliance	Description	Data	Compliance	Description	Data
N/A	Ramp Length (in)	60.0	Yes	Ramp Slope (%)	6.4
Yes	Ramp Width (in)	71.0	Yes	Ramp XSlope (%)	1.6
N/A	Flare Type LT	Sloped	N/A	Flare Type RT	N/A
N/A	Flare Slope LT (%)	6.8	N/A	Flare Slope RT (%)	15.7
N/A	Flare Traversable LT?	No	N/A	Flare Traversable RT?	No
Yes	Landing Length (in)	68.0	Yes	DWS Provided?	Yes
Yes	Landing Width (in)	72.0	Yes	DWS Contrast?	Yes
Yes	Landing Slope (%)	0.7	Yes	DWS Length (in)	24.0
Yes	Landing X Slope (%)	1.6	Yes	DWS Full Width?	Yes
N/A	Landing Curb? (Y/N)	N/A	Yes	DWS Offset (in)	0.0
N/A	Shared Landing?	Yes			
Yes	Gutter Ponding?	No	Yes	Gutter Slope (%)	1.2
Yes	Gutter Lip Ht (in)	0.0	No	Gutter X Slope (%)	3.7
N/A	Painted X Walk1?	Yes	N/A	Painted X Walk2?	N/A
	X Walk 1 Direction	To SE		X Walk 2 Direction	N/A
N/A	X Walk 1 Width (in)	96.0	N/A	X Walk 2 Width (in)	N/A
	X Walk 1 Slope (%)	5.3		X Walk 2 Slope (%)	N/A
	X Walk 1 X Slope (%)	3.3		X Walk 2 X Slope (%)	N/A

Yes	Ramp inside XWalk1?	Yes	N/A	Ramp inside XWalk2?	N/A
	Road Slope (%)	N/A	N/A	Clear Space?	Yes
	Road X Slope (%)	N/A	N/A	Clear Space to XWalk (in)	N/A
Yes	Any Obstructions?	No	Yes	Storm Grate/Utility Hazard?	No
	Obstruction Type			Storm Grate/Utility Type	
		N/A			N/A
			Yes	Surface Condition? (G/P)	Good

Possible Solutions:

Remove & Replace Gutter.

R304.5.3
