# Access Compliance Report

## Public Rights-of-Way

Intersection ID: 12404	Main Street: CHESTNUT_AV	Cross Street: PECAN_AV	Location: S
ADA ID: EA5D3AE76DCA	Ramp Type: Perp	Initial Pass/Fail: Fail	Overall Compliance: No
		Severity Score: 22.5	
Codes/Mitigation Info/Possible Solution		Field Measurements/Component Compliance

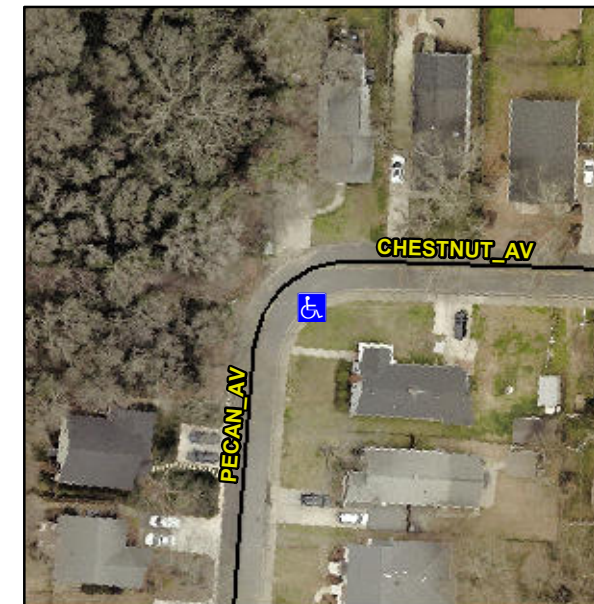
**Not Found, R304.5.1, R304.2.2, R304.5.3**

Compliance	Description	Data	Compliance	Description	Data
N/A	Ramp Length (in)	48.0	No	Ramp Slope (%)	10.5
No	Ramp Width (in)	47.0	No	Ramp XSlope (%)	2.2
N/A	Flare Type LT	N/A	N/A	Flare Type RT	N/A
N/A	Flare Slope LT (%)	N/A	N/A	Flare Slope RT (%)	N/A
N/A	Flare Traversable LT?	N/A	N/A	Flare Traversable RT?	N/A
N/A	Landing Length (in)	N/A	N/A	DWS Provided?	N/A
N/A	Landing Width (in)	N/A	N/A	DWS Contrast?	N/A
N/A	Landing Slope (%)	N/A	N/A	DWS Length (in)	N/A
N/A	Landing X Slope (%)	N/A	N/A	DWS Full Width?	N/A
N/A	Landing Curb? (Y/N)	N/A	N/A	DWS Offset (in)	N/A
N/A	Shared Landing?	N/A			
N/A	Gutter Ponding?	Yes	N/A	Gutter Slope (%)	N/A
N/A	Gutter Lip Ht (in)	N/A	N/A	Gutter X Slope (%)	N/A
N/A	Painted X Walk1?	No	N/A	Painted X Walk2?	N/A
	X Walk 1 Direction	To NW		X Walk 2 Direction	N/A
N/A	X Walk 1 Width (in)	N/A	N/A	X Walk 2 Width (in)	N/A
	X Walk 1 Slope (%)	5.0		X Walk 2 Slope (%)	N/A
	X Walk 1 X Slope (%)	1.5		X Walk 2 X Slope (%)	N/A

N/A	Ramp inside XWalk1?	N/A	N/A	Ramp inside XWalk2?	N/A
	Road Slope (%)	1.5	N/A	Clear Space?	N/A
	Road X Slope (%)	5.0	N/A	Clear Space to XWalk (in)	N/A
N/A	Any Obstructions?	N/A	N/A	Storm Grate/Utility Hazard?	N/A
	Obstruction Type			Storm Grate/Utility Type	
		N/A			N/A
			Yes	Surface Condition? (G/P)	Good

**Remove & Replace Entire Ramp.**
