# Access Compliance Report

## Public Rights-of-Way

### (Curb Ramps)

Intersection ID: 47015	Main Street: TRIBUNE_DR	Cross Street: KRAUS_GLEN_DR	Location: E
ADA ID: EA63A5348045	Ramp Type: BlendTrans1	Initial Pass/Fail: Fail	Overall Compliance: No
		Severity Score: 10

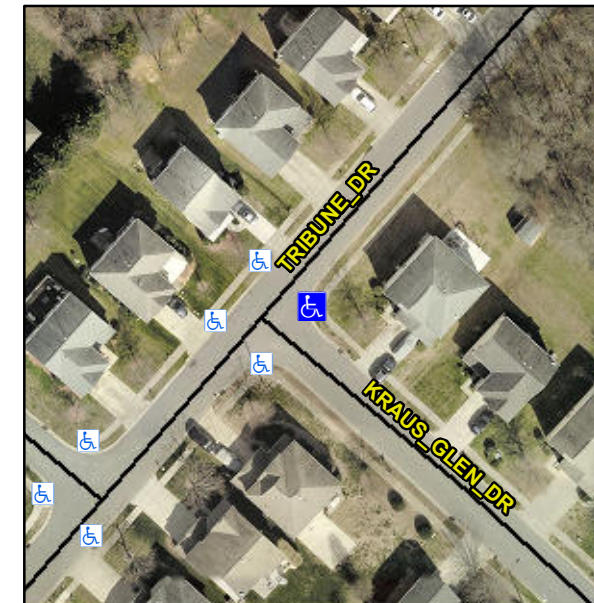
**Not Found, R304.5.1, R304.5.3**

Compliance	Description	Data	Compliance	Description	Data
N/A	Ramp Length (in)	46.0	Yes	BlendTrans Slope (%)	2.0
No	Ramp Width (in)	47.0	No	BlendTrans XSlope (%)	2.6
N/A	Flare Type LT	N/A	N/A	Flare Type RT	N/A
N/A	Flare Slope LT (%)	N/A	N/A	Flare Slope RT (%)	N/A
N/A	Flare Traversable LT?	N/A	N/A	Flare Traversable RT?	N/A
N/A	Landing Length (in)	N/A	N/A	DWS Provided?	N/A
N/A	Landing Width (in)	N/A	N/A	DWS Contrast?	N/A
N/A	Landing Slope (%)	N/A	N/A	DWS Length (in)	N/A
N/A	Landing X Slope (%)	N/A	N/A	DWS Full Width?	N/A
N/A	Landing Curb? (Y/N)	N/A	N/A	DWS Offset (in)	N/A
N/A	Shared Landing?	N/A			
N/A	Gutter Ponding?	N/A	N/A	Gutter Slope (%)	N/A
N/A	Gutter Lip Ht (in)	N/A	N/A	Gutter X Slope (%)	N/A
N/A	Painted X Walk1?	No	N/A	Painted X Walk2?	No
	X Walk 1 Direction	To NW		X Walk 2 Direction	To SW
	X Walk 1 Width (in)	N/A		X Walk 2 Width (in)	N/A
	X Walk 1 Slope (%)	2.4		X Walk 2 Slope (%)	2.1
	X Walk 1 X Slope (%)	2.4		X Walk 2 X Slope (%)	0.7

N/A	Ramp inside XWalk1?	N/A	N/A	Ramp inside XWalk2?	N/A
	Road Slope (%)	1.9		Clear Space?	N/A
	Road X Slope (%)	3.2	N/A	Clear Space to XWalk (in)	N/A
N/A	Any Obstructions?	N/A	N/A	Storm Grate/Utility Hazard?	N/A
	Obstruction Type			Storm Grate/Utility Type	
		N/A			N/A
			Yes	Surface Condition? (G/P)	Good
			No	Curb Slope (%)	6.9

**Remove & Replace Curb Ramp With Two New Directional Ramps or Equivalent.**
