Access Compliance Report

Public Rights-of-Way

(Curb Ramps)

Intersection ID: 3423	Main Street: OVERLOOK_MOUNTAIN_DR	Cross Street: SOLEMN_POINTE_LN	Location: NW
ADA ID: EA7705A40503	Ramp Type: Perp	Initial Pass/Fail: Fail	Overall Compliance: No
Severity Score: 8.75			
Codes/Mitigation Info/Possible Solution		Field Measurements/Component Compliance

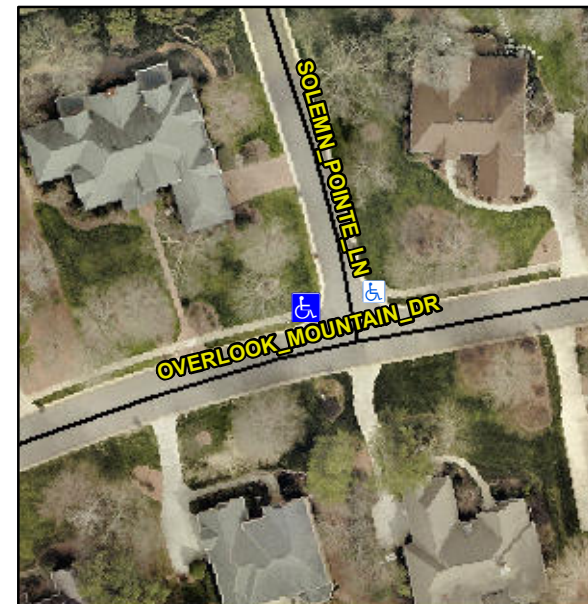
Compliance	Description	Data	Compliance	Description	Data
N/A	Ramp Length (in)	95.0	Yes	Ramp Slope (%)	7.2
No	Ramp Width (in)	44.0	Yes	Ramp XSlope (%)	0.1
N/A	Flare Type LT	N/A	N/A	Flare Type RT	N/A
N/A	Flare Slope LT (%)	N/A	N/A	Flare Slope RT (%)	N/A
N/A	Flare Traversable LT?	N/A	N/A	Flare Traversable RT?	N/A
N/A	Landing Length (in)	N/A	N/A	DWS Provided?	N/A
N/A	Landing Width (in)	N/A	N/A	DWS Contrast?	N/A
N/A	Landing Slope (%)	N/A	N/A	DWS Length (in)	N/A
N/A	Landing X Slope (%)	N/A	N/A	DWS Full Width?	N/A
N/A	Landing Curb? (Y/N)	N/A	N/A	DWS Offset (in)	N/A
N/A	Shared Landing?	N/A			
N/A	Gutter Ponding?	N/A	N/A	Gutter Slope (%)	N/A
N/A	Gutter Lip Ht (in)	N/A	N/A	Gutter X Slope (%)	N/A
N/A	Painted X Walk1?	No	N/A	Painted X Walk2?	N/A
	X Walk 1 Direction	To E		X Walk 2 Direction	N/A
N/A	X Walk 1 Width (in)	N/A	N/A	X Walk 2 Width (in)	N/A
	X Walk 1 Slope (%)	0.2		X Walk 2 Slope (%)	N/A
	X Walk 1 X Slope (%)	2.4		X Walk 2 X Slope (%)	N/A

N/A	Ramp inside XWalk1?	N/A	N/A	Ramp inside XWalk2?	N/A
	Road Slope (%)	N/A	N/A	Clear Space?	N/A
	Road X Slope (%)	N/A	N/A	Clear Space to XWalk (in)	N/A
N/A	Any Obstructions?	N/A	N/A	Storm Grate/Utility Hazard?	N/A
	Obstruction Type			Storm Grate/Utility Type	
		N/A			N/A
			Yes	Surface Condition? (G/P)	Good

Possible Solutions:

Remove & Replace Entire Ramp.

R304.5.1
