# Access Compliance Report

## Public Rights-of-Way

### (Curb Ramps)

Intersection ID: 10024956	Main Street: DISTRICT_SOUTH_DR	Cross Street: N/A	Location:	N
ADA ID: EA8768B68A45	Ramp Type: Perp	Initial Pass/Fail: Fail	Overall Compliance: No	Severity Score: 12.5
Codes/Mitigation Info/Possible Solution		Field Measurements/Component Compliance

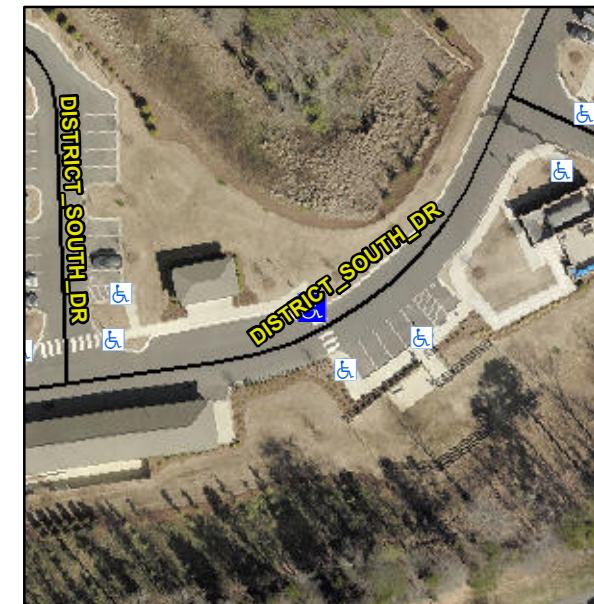
**Not Found, R304.5.3**

Compliance	Description	Data	Compliance	Description	Data
N/A	Ramp Length (in)	69.0	Yes	Ramp Slope (%)	6.7
Yes	Ramp Width (in)	59.0	No	Ramp XSlope (%)	5.5
N/A	Flare Type LT	N/A	N/A	Flare Type RT	N/A
N/A	Flare Slope LT (%)	N/A	N/A	Flare Slope RT (%)	N/A
N/A	Flare Traversable LT?	N/A	N/A	Flare Traversable RT?	N/A
N/A	Landing Length (in)	N/A	N/A	DWS Provided?	N/A
N/A	Landing Width (in)	N/A	N/A	DWS Contrast?	N/A
N/A	Landing Slope (%)	N/A	N/A	DWS Length (in)	N/A
N/A	Landing X Slope (%)	N/A	N/A	DWS Full Width?	N/A
N/A	Landing Curb? (Y/N)	N/A	N/A	DWS Offset (in)	N/A
N/A	Shared Landing?	N/A			
N/A	Gutter Ponding?	N/A	N/A	Gutter Slope (%)	N/A
N/A	Gutter Lip Ht (in)	N/A	N/A	Gutter X Slope (%)	N/A
N/A	Painted X Walk1?	Yes	N/A	Painted X Walk2?	N/A
	X Walk 1 Direction	To S		X Walk 2 Direction	N/A
N/A	X Walk 1 Width (in)	91.0	N/A	X Walk 2 Width (in)	N/A
	X Walk 1 Slope (%)	1.8		X Walk 2 Slope (%)	N/A
	X Walk 1 X Slope (%)	0.7		X Walk 2 X Slope (%)	N/A

N/A	Ramp inside XWalk1?	Yes	N/A	Ramp inside XWalk2?	N/A
	Road Slope (%)	N/A	N/A	Clear Space?	N/A
	Road X Slope (%)	N/A	N/A	Clear Space to XWalk (in)	N/A
N/A	Any Obstructions?	N/A	N/A	Storm Grate/Utility Hazard?	N/A
	Obstruction Type			Storm Grate/Utility Type	
		N/A			N/A
			Yes	Surface Condition? (G/P)	Good

**Remove & Replace Entire Ramp.**
