Access Compliance Report

Public Rights-of-Way

(Curb Ramps)

Intersection ID: 50008	Main Street: BERKELEY_PLACE_DR	Cross Street: SALERNO_DR	Location: E
ADA ID: EA89E0B437BD	Ramp Type: PerpDiag	Initial Pass/Fail: Fail	Overall Compliance: No
Severity Score: 13.75			
Codes/Mitigation Info/Possible Solution		Field Measurements/Component Compliance

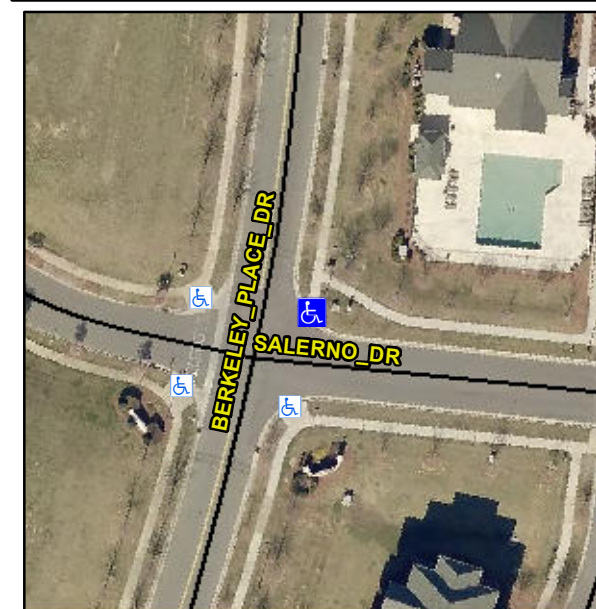
PROW/ADA:

R304.2.2, R304.5.3

Compliance	Description	Data	Compliance	Description	Data
N/A	Ramp Length (in)	55.0	No	Ramp Slope (%)	10.0
Yes	Ramp Width (in)	48.0	No	Ramp XSlope (%)	4.9
N/A	Flare Type LT	N/A	N/A	Flare Type RT	N/A
N/A	Flare Slope LT (%)	N/A	N/A	Flare Slope RT (%)	N/A
N/A	Flare Traversable LT?	N/A	N/A	Flare Traversable RT?	N/A
N/A	Landing Length (in)	N/A	N/A	DWS Provided?	N/A
N/A	Landing Width (in)	N/A	N/A	DWS Contrast?	N/A
N/A	Landing Slope (%)	N/A	N/A	DWS Length (in)	N/A
N/A	Landing X Slope (%)	N/A	N/A	DWS Full Width?	N/A
N/A	Landing Curb? (Y/N)	N/A	N/A	DWS Offset (in)	N/A
N/A	Shared Landing?	N/A			
N/A	Gutter Ponding?	N/A	N/A	Gutter Slope (%)	N/A
N/A	Gutter Lip Ht (in)	N/A	N/A	Gutter X Slope (%)	N/A
N/A	Painted X Walk1?	No	N/A	Painted X Walk2?	No
	X Walk 1 Direction	To NW		X Walk 2 Direction	To SW
N/A	X Walk 1 Width (in)	N/A	N/A	X Walk 2 Width (in)	N/A
	X Walk 1 Slope (%)	7.1		X Walk 2 Slope (%)	4.0
	X Walk 1 X Slope (%)	2.3		X Walk 2 X Slope (%)	6.9

N/A	Ramp inside XWalk1?	N/A	N/A	Ramp inside XWalk2?	N/A
	Road Slope (%)	5.3	N/A	Clear Space?	N/A
	Road X Slope (%)	6.7	N/A	Clear Space to XWalk (in)	N/A
N/A	Any Obstructions?	N/A	N/A	Storm Grate/Utility Hazard?	N/A
	Obstruction Type			Storm Grate/Utility Type	
		N/A			N/A
			Yes	Surface Condition? (G/P)	Good

Possible Solutions:

Remove & Replace Curb Ramp With Two New Directional Ramps or Equivalent.
