Access Compliance Report

Public Rights-of-Way

(Curb Ramps)

Intersection ID: 14844	Main Street: DILWORTH RD WEST	Cross Street: EAST BV	Location: NE
ADA ID: EA9B0B149731	Ramp Type: Perp	Initial Pass/Fail: Fail	Overall Compliance: No
			Severity Score: 25

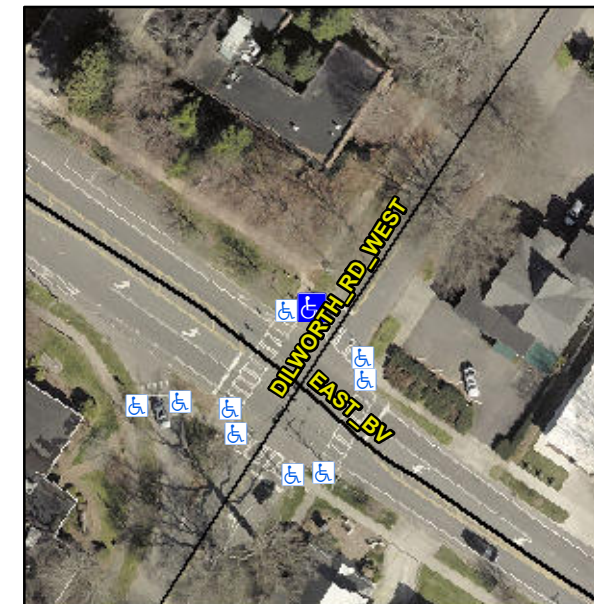
Not Found, R304.2.2, R304.5.3

Compliance	Description	Data	Compliance	Description	Data
N/A	Ramp Length (in)	72.5	No	Ramp Slope (%)	8.5
Yes	Ramp Width (in)	72.0	No	Ramp XSlope (%)	5.3
N/A	Flare Type LT	N/A	N/A	Flare Type RT	N/A
N/A	Flare Slope LT (%)	N/A	N/A	Flare Slope RT (%)	N/A
N/A	Flare Traversable LT?	N/A	N/A	Flare Traversable RT?	N/A
N/A	Landing Length (in)	N/A	N/A	DWS Provided?	N/A
N/A	Landing Width (in)	N/A	N/A	DWS Contrast?	N/A
N/A	Landing Slope (%)	N/A	N/A	DWS Length (in)	N/A
N/A	Landing X Slope (%)	N/A	N/A	DWS Full Width?	N/A
N/A	Landing Curb? (Y/N)	N/A	N/A	DWS Offset (in)	N/A
N/A	Shared Landing?	N/A			
N/A	Gutter Ponding?	N/A	N/A	Gutter Slope (%)	N/A
N/A	Gutter Lip Ht (in)	N/A	N/A	Gutter X Slope (%)	N/A
N/A	Painted X Walk1?	Yes	N/A	Painted X Walk2?	N/A
	X Walk 1 Direction	To SE		X Walk 2 Direction	N/A
N/A	X Walk 1 Width (in)	112.0	N/A	X Walk 2 Width (in)	N/A
	X Walk 1 Slope (%)	1.0		X Walk 2 Slope (%)	N/A
	X Walk 1 X Slope (%)	4.4		X Walk 2 X Slope (%)	N/A

N/A	Ramp inside XWalk1?	Yes	N/A	Ramp inside XWalk2?	N/A
	Road Slope (%)	N/A	N/A	Clear Space?	N/A
	Road X Slope (%)	N/A	N/A	Clear Space to XWalk (in)	N/A
N/A	Any Obstructions?	N/A	N/A	Storm Grate/Utility Hazard?	N/A
	Obstruction Type			Storm Grate/Utility Type	
		N/A			N/A
			Yes	Surface Condition? (G/P)	Good

Remove & Replace Entire Ramp.
