Access Compliance Report

Public Rights-of-Way

(Curb Ramps)

Intersection ID: 10033070	Main Street: NORTH_COMMUNITY_HOUSE_RD	Cross Street: N/A	Location: NW
ADA ID: EAA6D4DE15CA	Ramp Type: Perp	Initial Pass/Fail: Fail	Overall Compliance: No
			Severity Score: 13.75

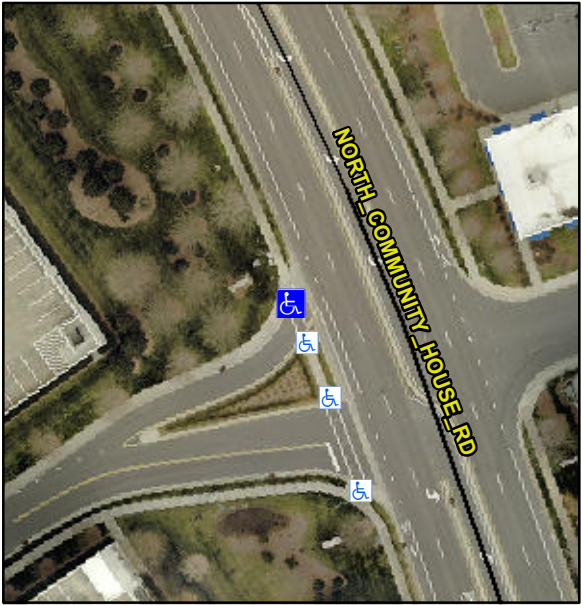
Possible Solutions:		Compliance	Description	Data
	Remove & Replace Entire Ramp.		No	Ramp Length (in)	60.0
			Yes	Ramp Width (in)	62.0
			N/A	Flare Type LT	N/A
			N/A	Flare Slope LT (%)	N/A
			N/A	Flare Traversable LT?	N/A
			N/A	Landing Length (in)	N/A
			N/A	Landing Width (in)	N/A
			N/A	Landing Slope (%)	N/A
			N/A	Landing X Slope (%)	N/A
<p>Surveyor Notes:</p> <p>N/A</p> <p>PROW/ADA:</p> <p>Not Found, R304.2.2, R304.5.3</p>			N/A	Flare Type RT	N/A
			N/A	Flare Slope RT (%)	N/A
			N/A	Flare Traversable RT?	N/A
			N/A	DWS Provided?	N/A
			N/A	DWS Contrast?	N/A
			N/A	DWS Length (in)	N/A
			N/A	DWS Full Width?	N/A
			N/A	DWS Offset (in)	N/A
			N/A	Gutter Ponding?	N/A
			N/A	Gutter Lip Ht (in)	N/A
			Yes	Painted X Walk1?	N/A
				X Walk 1 Direction	To SE
			N/A	X Walk 1 Width (in)	76.0
				X Walk 1 Slope (%)	4.6
				X Walk 1 X Slope (%)	3.5

N/A	Ramp inside XWalk1?	Yes
			N/A	Road Slope (%)	N/A
			N/A	Road X Slope (%)	N/A
			N/A	Any Obstructions?	N/A
				Obstruction Type	
Total Cost:					
			\$	1850.00	
			N/A		N/A
			Yes	Surface Condition? (G/P)	Good
