Access Compliance Report

Public Rights-of-Way

(Curb Ramps)

Intersection ID: 11783	Main Street: N_GRAHAM_ST	Cross Street: W_5TH_ST	Location: N
ADA ID: EACD401EA3B3	Ramp Type: BlendTrans1	Initial Pass/Fail: Pass	Overall Compliance: No
			Severity Score: 5

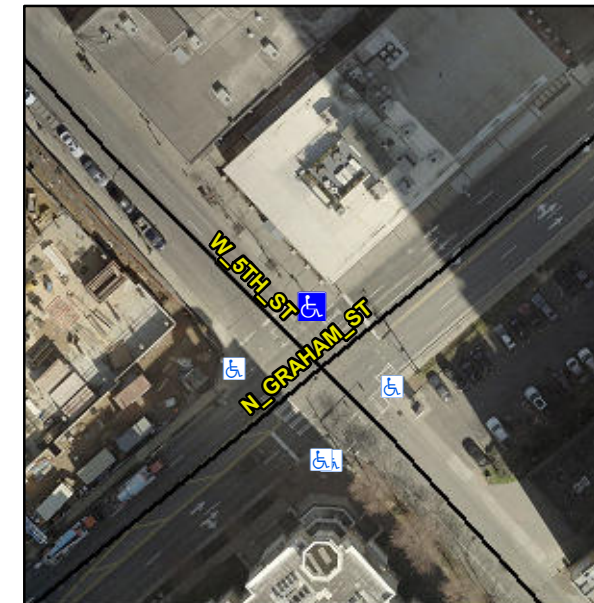
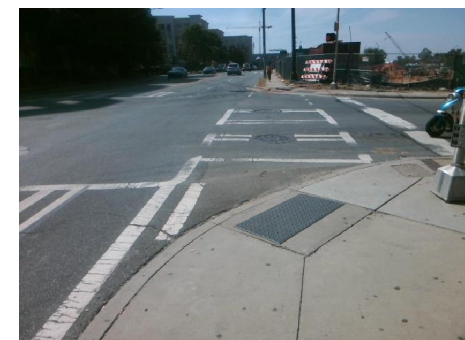
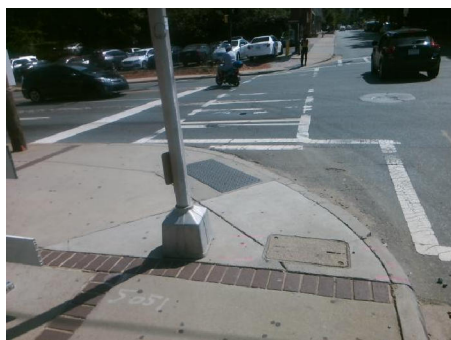
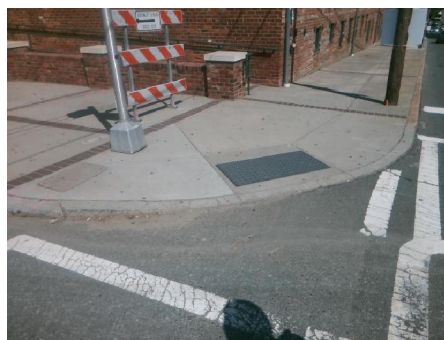
R304.5.3, Not Found, R305.2, R304.5.4

Compliance	Description	Data	Compliance	Description	Data
N/A	Ramp Length (in)	44.0	Yes	BlendTrans Slope (%)	0.4
Yes	Ramp Width (in)	50.0	Yes	BlendTrans XSlope (%)	0.5
N/A	Flare Type LT	Sloped	N/A	Flare Type RT	Sloped
Yes	Flare Slope LT (%)	5.4	Yes	Flare Slope RT (%)	2.1
N/A	Flare Traversable LT?	Yes	N/A	Flare Traversable RT?	Yes
Yes	Landing Length (in)	60.0	Yes	DWS Provided?	Yes
Yes	Landing Width (in)	50.0	Yes	DWS Contrast?	Yes
Yes	Landing Slope (%)	0.2	Yes	DWS Length (in)	24.0
No	Landing X Slope (%)	2.8	Yes	DWS Full Width?	Yes
N/A	Landing Curb? (Y/N)	No	No	DWS Offset (in)	8.0
N/A	Shared Landing?	No			
Yes	Gutter Ponding?	No	No	Gutter Slope (%)	6.2
Yes	Gutter Lip Ht (in)	0.0	Yes	Gutter X Slope (%)	1.4
N/A	Painted X Walk1?	Yes	N/A	Painted X Walk2?	Yes
	X Walk 1 Direction	To SW		X Walk 2 Direction	To SE
	X Walk 1 Width (in)	108.0		X Walk 2 Width (in)	110.0
	X Walk 1 Slope (%)	5.0		X Walk 2 Slope (%)	0.9
	X Walk 1 X Slope (%)	5.0		X Walk 2 X Slope (%)	5.2

Yes	Ramp inside XWalk1?	Yes	Yes	Ramp inside XWalk2?	Yes
	Road Slope (%)	1.1		Clear Space?	Yes
	Road X Slope (%)	6.6	No	Clear Space to XWalk (in)	45.0
Yes	Any Obstructions?	No	Yes	Storm Grate/Utility Hazard?	No
	Obstruction Type			Storm Grate/Utility Type	
		N/A			N/A
			Yes	Surface Condition? (G/P)	Good
			Yes	Curb Slope (%)	0.8

Remove & Replace Curb Ramp With Two New Directional Ramps or Equivalent. Restripe Crosswalk(s) To Provide Clear space. Remove & Replace Gutter.
