Access Compliance Report Public Rights-of-Way (Curb Ramps)

Intersection ID: 18735 Main Street: JESTER_LN Cross Street: REDCOAT_DR Location: NE

ADA ID: EAD33F56F9C8 Ramp Type: PerpDiag Initial Pass/Fail: Fail Overall Compliance: No Severity Score: 12.5

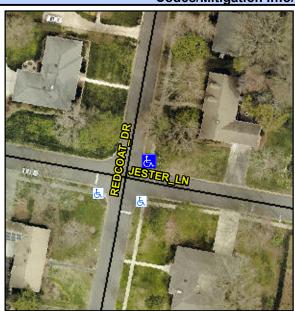
Field Measurements/Component Compliance					
Compliance Description		Data	Comp	oliance Description	Data
N/A	A Ramp Length (in)	72.0	No	Ramp Slope (%)	10.1
Ye	Ramp Width (in)	48.0	Yes	Ramp XSlope (%)	1.1
N/A	A Flare Type LT	N/A	N/A	Flare Type RT	N/A
N/A	A Flare Slope LT (%)	N/A	N/A	Flare Slope RT (%)	N/A
N/A	Flare Traversable LT?	N/A	N/A	Flare Traversable RT?	N/A
N/A	Landing Length (in)	N/A	N/A	DWS Provided?	N/A
N/A	Landing Width (in)	N/A	N/A	DWS Contrast?	N/A
N/A	Landing Slope (%)	N/A	N/A	DWS Length (in)	N/A
N/A	Landing X Slope (%)	N/A	N/A	DWS Full Width?	N/A
N/A	Landing Curb? (Y/N)	N/A	N/A	DWS Offset (in)	N/A
N/A	A Shared Landing?	N/A			
N/A	Gutter Ponding?	N/A	N/A	Gutter Slope (%)	N/A
N/A	Gutter Lip Ht (in)	N/A	N/A	Gutter X Slope (%)	N/A
N/A	A Painted X Walk1?	No	N/A	Painted X Walk2?	No
	X Walk 1 Direction	To NW		X Walk 2 Direction	To SW
N/A	X Walk 1 Width (in)	N/A	N/A	X Walk 2 Width (in)	N/A
	X Walk 1 Slope (%)	1.2		X Walk 2 Slope (%)	0.2

X Walk 1 X Slope (%)	2.5		X Walk 2 X Slope (%)	2.3
N/A	Ramp inside XWalk1?	N/A	N/A	Ramp inside XWalk2?	N/A
	Road Slope (%)	2.4	N/A	Clear Space?	N/A
	Road X Slope (%)	0.2	N/A	Clear Space to XWalk (in)	N/A
N/A	Any Obstructions?	N/A	N/A	Storm Grate/Utility Hazard?	N/A
	Obstruction Type			Storm Grate/Utility Type	
		N/A			N/A
			Yes	Surface Condition? (G/P)	Good
	100	·

Codes/Mitigation Info/Possible Solution

Total Cost: \$ 3200.00
