Access Compliance Report

Public Rights-of-Way

(Curb Ramps)

Intersection ID: 18011	Main Street: PARK_RD	Cross Street: HEATHER_LN	Location: SW
ADA ID: EADB227F9EF7	Ramp Type: BlendTrans2	Initial Pass/Fail: Fail	Overall Compliance: No
		Severity Score: 21.25

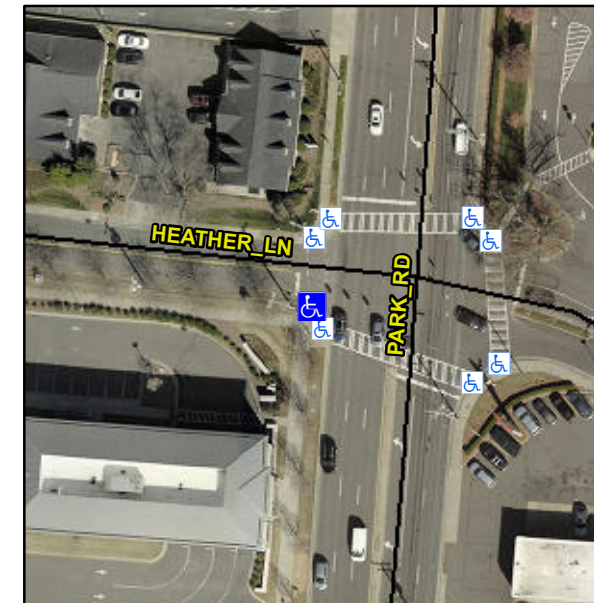
Not Found, R304.5.1, R304.5.3

Compliance	Description	Data	Compliance	Description	Data
N/A	Ramp Length (in)	118.0	Yes	BlendTrans Slope (%)	0.9
No	Ramp Width (in)	47.5	No	BlendTrans XSlope (%)	5.1
N/A	Flare Type LT	N/A	N/A	Flare Type RT	N/A
N/A	Flare Slope LT (%)	N/A	N/A	Flare Slope RT (%)	N/A
N/A	Flare Traversable LT?	N/A	N/A	Flare Traversable RT?	N/A
N/A	Landing Length (in)	N/A	N/A	DWS Provided?	N/A
N/A	Landing Width (in)	N/A	N/A	DWS Contrast?	N/A
N/A	Landing Slope (%)	N/A	N/A	DWS Length (in)	N/A
N/A	Landing X Slope (%)	N/A	N/A	DWS Full Width?	N/A
N/A	Landing Curb? (Y/N)	N/A	N/A	DWS Offset (in)	N/A
N/A	Shared Landing?	N/A			
N/A	Gutter Ponding?	N/A	N/A	Gutter Slope (%)	N/A
N/A	Gutter Lip Ht (in)	N/A	N/A	Gutter X Slope (%)	N/A
N/A	Painted X Walk1?	No	N/A	Painted X Walk2?	N/A
	X Walk 1 Direction	To N		X Walk 2 Direction	N/A
	X Walk 1 Width (in)	N/A		X Walk 2 Width (in)	N/A
	X Walk 1 Slope (%)	0.7		X Walk 2 Slope (%)	N/A
	X Walk 1 X Slope (%)	6.0		X Walk 2 X Slope (%)	N/A

N/A	Ramp inside XWalk1?	N/A	N/A	Ramp inside XWalk2?	N/A
	Road Slope (%)	6.0		Clear Space?	N/A
	Road X Slope (%)	0.7	N/A	Clear Space to XWalk (in)	N/A
N/A	Any Obstructions?	N/A	N/A	Storm Grate/Utility Hazard?	N/A
	Obstruction Type			Storm Grate/Utility Type	
		N/A			N/A
			Yes	Surface Condition? (G/P)	Good
			No	Curb Slope (%)	11.6

Remove & Replace Curb Ramp With Two New Directional Ramps or Equivalent.
