Access Compliance Report

Public Rights-of-Way

(Curb Ramps)

Intersection ID: 17705	Main Street: FOREST_WAY_DR	Cross Street: OLD_POST_RD	Location: NE
ADA ID: EAE25D4FC1F5	Ramp Type: Directional1	Initial Pass/Fail: Pass	Overall Compliance: No
		Severity Score: 2.75

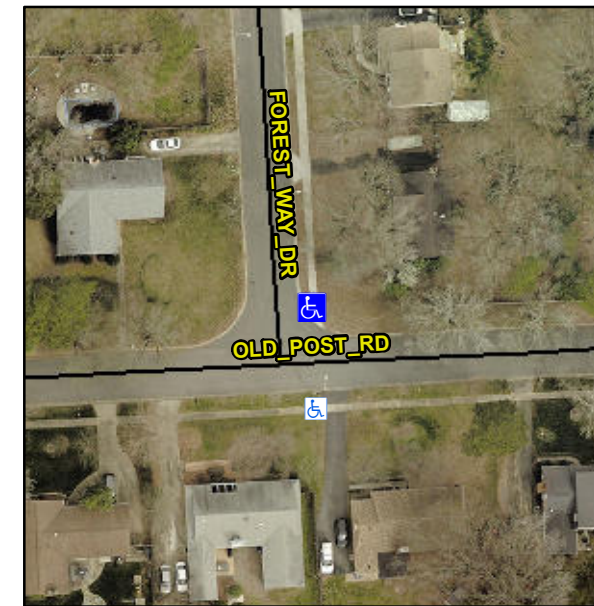
Surveyor Notes:

N/A

PROW/ADA:

Not Found, R304.2.2-Perp, R304.3.2-Para, R305.1.4, R305.2

Compliance	Description	Data	Compliance	Description	Data
N/A	Ramp Length (in)	59.5	Yes	Grade Break?	Yes
Yes	Ramp Width (in)	60.0	Yes	Grade Break Slope (%)	1.3
Yes	Ramp Slope (%)	1.0	Yes	Grade Break XSlope (%)	0.3
Yes	Ramp XSlope (%)	2.6			
N/A	Flare Type LT	N/A	N/A	Flare Type RT	N/A
N/A	Flare Slope LT (%)	N/A	N/A	Flare Slope RT (%)	N/A
N/A	Flare Traversable LT?	N/A	N/A	Flare Traversable RT?	N/A
Yes	Landing Length (in)	59.0	Yes	DWS Provided?	Yes
Yes	Landing Width (in)	59.5	Yes	DWS Contrast?	Yes
No	Landing Slope (%)	2.8	Yes	DWS Length (in)	24.0
Yes	Landing X Slope (%)	1.1	No	DWS Full Width?	No
N/A	Landing Curb? (Y/N)	No	No	DWS Offset LT (in)	11.0
N/A	Shared Landing?	No	No	DWS Offset RT (in)	63.0
Yes	Gutter Ponding?	No	Yes	Gutter Slope (%)	0.1
Yes	Gutter Lip Ht (in)	0.0	Yes	Gutter X Slope (%)	1.3
N/A	Painted X Walk1?	No		Road Slope (%)	5.8
	X Walk 1 Direction	To S		Road X Slope (%)	6.3
	X Walk 1 Width (in)	N/A		Clear Space?	Yes

X Walk 1 Slope (%)	5.8	N/A	Clear Space to XWalk (in)	N/A
	X Walk 1 X Slope (%)	6.3	Yes	Storm Grate/Utility Hazard?	No
N/A	Ramp inside XWalk1?	N/A		Storm Grate/Utility Type	
Yes	Any Obstructions?	No			N/A
	Obstruction Type		Yes	Surface Condition? (G/P)	Good
			N/A	Curb Slope (%)	10.0

Possible Solutions:

Remove & Replace Entire Ramp.

Total Cost: \$ 1600.00

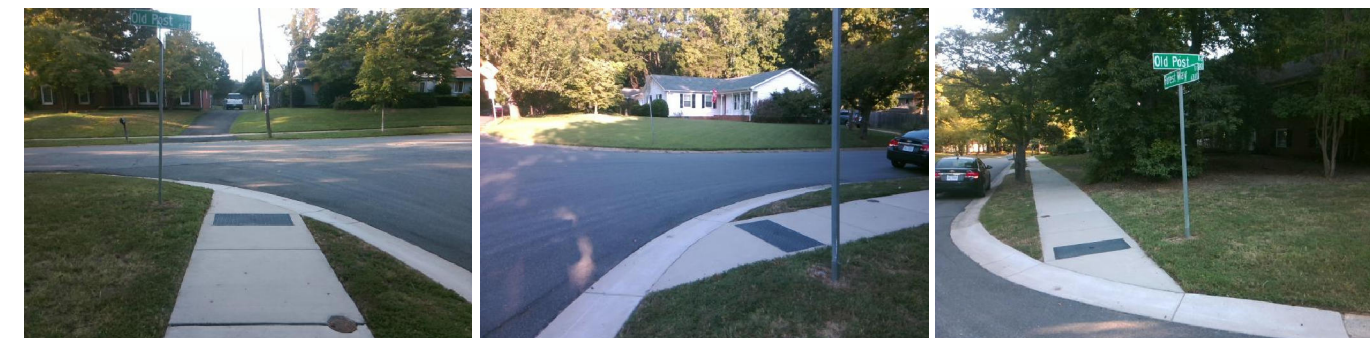
Street 1 Name	OLD POST RD
Stop Condition-Street 1	None
Street 2 Name	N/A
Stop Condition-Street 2	N/A
