Access Compliance Report

Public Rights-of-Way

(Curb Ramps)

Intersection ID: 20407	Main Street: CAMERON_VALLEY_PY	Cross Street: COLTSGATE_RD	Location: E
ADA ID: EAE631825713	Ramp Type: PerpDiag	Initial Pass/Fail: Fail	Overall Compliance: No
		Severity Score: 8.75

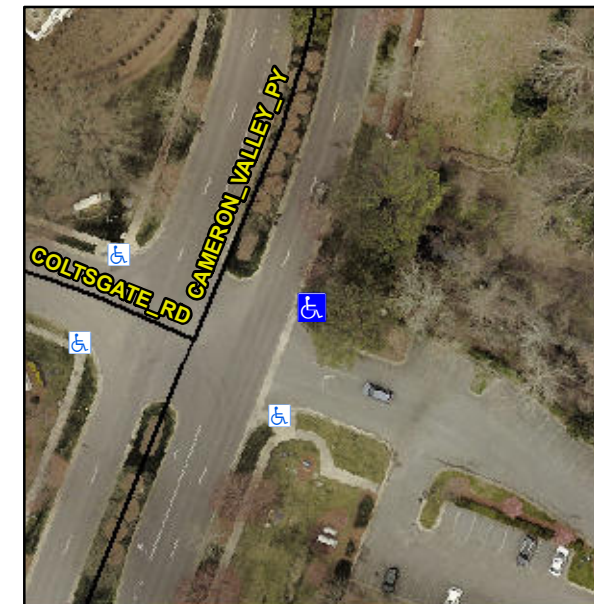
Compliance	Description	Data	Compliance	Description	Data
N/A	Ramp Length (in)	58.0	Yes	Ramp Slope (%)	7.5
No	Ramp Width (in)	38.0	Yes	Ramp XSlope (%)	0.4
N/A	Flare Type LT	N/A	N/A	Flare Type RT	N/A
N/A	Flare Slope LT (%)	N/A	N/A	Flare Slope RT (%)	N/A
N/A	Flare Traversable LT?	N/A	N/A	Flare Traversable RT?	N/A
N/A	Landing Length (in)	N/A	N/A	DWS Provided?	N/A
N/A	Landing Width (in)	N/A	N/A	DWS Contrast?	N/A
N/A	Landing Slope (%)	N/A	N/A	DWS Length (in)	N/A
N/A	Landing X Slope (%)	N/A	N/A	DWS Full Width?	N/A
N/A	Landing Curb? (Y/N)	N/A	N/A	DWS Offset (in)	N/A
N/A	Shared Landing?	N/A			
N/A	Gutter Ponding?	N/A	N/A	Gutter Slope (%)	N/A
N/A	Gutter Lip Ht (in)	N/A	N/A	Gutter X Slope (%)	N/A
N/A	Painted X Walk1?	No	N/A	Painted X Walk2?	No
	X Walk 1 Direction	To NW		X Walk 2 Direction	To SW
N/A	X Walk 1 Width (in)	N/A	N/A	X Walk 2 Width (in)	N/A
	X Walk 1 Slope (%)	2.4		X Walk 2 Slope (%)	0.3
	X Walk 1 X Slope (%)	0.2		X Walk 2 X Slope (%)	1.6

N/A	Ramp inside XWalk1?	N/A	N/A	Ramp inside XWalk2?	N/A
	Road Slope (%)	1.1	N/A	Clear Space?	N/A
	Road X Slope (%)	0.3	N/A	Clear Space to XWalk (in)	N/A
N/A	Any Obstructions?	N/A	N/A	Storm Grate/Utility Hazard?	N/A
	Obstruction Type			Storm Grate/Utility Type	
		N/A			N/A
			Yes	Surface Condition? (G/P)	Good

Possible Solutions:

Remove & Replace Curb Ramp With Two New Directional Ramps or Equivalent.
