Access Compliance Report

Public Rights-of-Way

(Curb Ramps)

Intersection ID: 29933	Main Street: CAROLINA_LILY_LN	Cross Street: APPLIEDALE_DR	Location: SE
ADA ID: EAEAB2F1D096	Ramp Type: BlendTrans1	Initial Pass/Fail: Fail	Overall Compliance: No
		Severity Score: 12.5

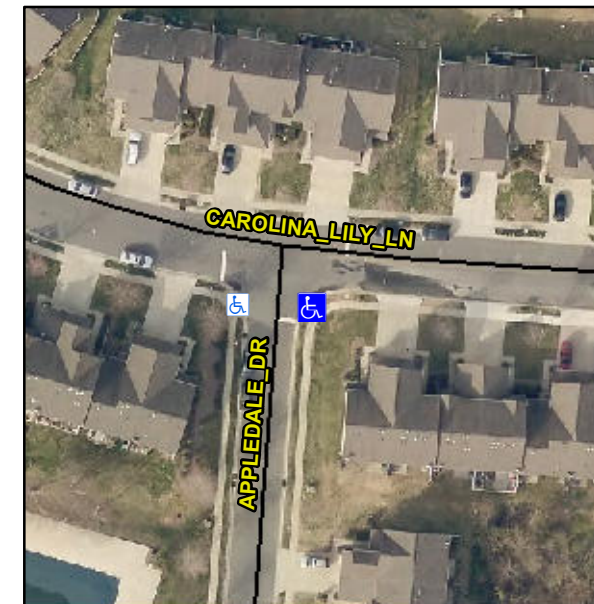
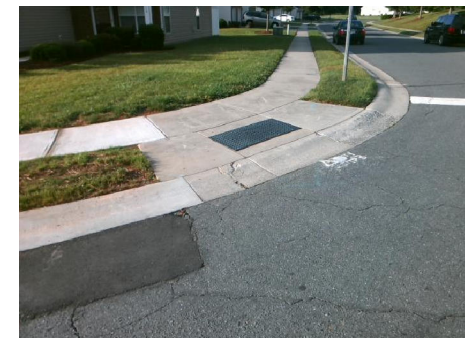
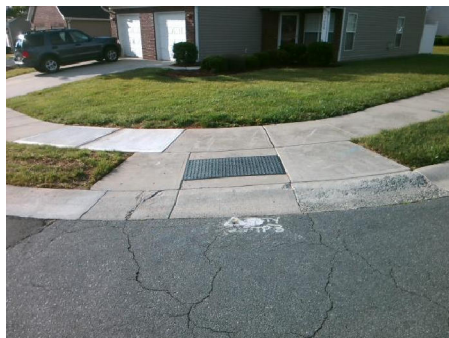
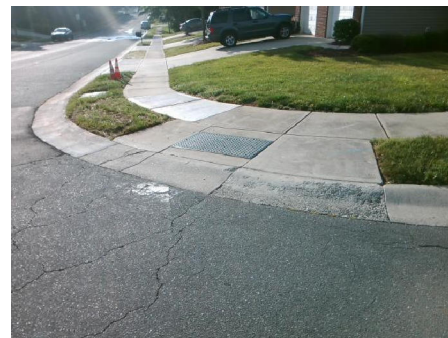
Not Found, R304.5.3

Compliance	Description	Data	Compliance	Description	Data
N/A	Ramp Length (in)	48.0	Yes	BlendTrans Slope (%)	3.0
Yes	Ramp Width (in)	126.0	No	BlendTrans XSlope (%)	5.7
N/A	Flare Type LT	N/A	N/A	Flare Type RT	N/A
N/A	Flare Slope LT (%)	N/A	N/A	Flare Slope RT (%)	N/A
N/A	Flare Traversable LT?	N/A	N/A	Flare Traversable RT?	N/A
N/A	Landing Length (in)	N/A	N/A	DWS Provided?	N/A
N/A	Landing Width (in)	N/A	N/A	DWS Contrast?	N/A
N/A	Landing Slope (%)	N/A	N/A	DWS Length (in)	N/A
N/A	Landing X Slope (%)	N/A	N/A	DWS Full Width?	N/A
N/A	Landing Curb? (Y/N)	N/A	N/A	DWS Offset (in)	N/A
N/A	Shared Landing?	N/A			
N/A	Gutter Ponding?	N/A	N/A	Gutter Slope (%)	N/A
N/A	Gutter Lip Ht (in)	N/A	N/A	Gutter X Slope (%)	N/A
N/A	Painted X Walk1?	No	N/A	Painted X Walk2?	No
	X Walk 1 Direction	To N		X Walk 2 Direction	To W
	X Walk 1 Width (in)	N/A		X Walk 2 Width (in)	N/A
	X Walk 1 Slope (%)	2.2		X Walk 2 Slope (%)	4.2
	X Walk 1 X Slope (%)	5.8		X Walk 2 X Slope (%)	4.0

N/A	Ramp inside XWalk1?	N/A	N/A	Ramp inside XWalk2?	N/A
	Road Slope (%)	5.1		Clear Space?	N/A
	Road X Slope (%)	0.0	N/A	Clear Space to XWalk (in)	N/A
N/A	Any Obstructions?	N/A	N/A	Storm Grate/Utility Hazard?	N/A
	Obstruction Type			Storm Grate/Utility Type	
		N/A			N/A
			Yes	Surface Condition? (G/P)	Good
			No	Curb Slope (%)	19.7

Remove & Replace Curb Ramp With Two New Directional Ramps or Equivalent.
