Access Compliance Report

Public Rights-of-Way

(Curb Ramps)

Intersection ID: 54465	Main Street: RUPELL_DR	Cross Street: COLLINGHAM_DR	Location: SE
ADA ID: EAF2380B46CB	Ramp Type: BlendTrans1	Initial Pass/Fail: Fail	Overall Compliance: No
		Severity Score: 1.25

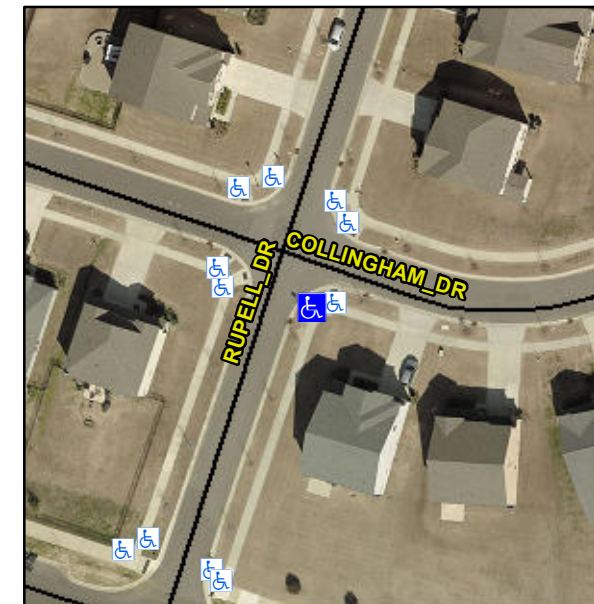
Not Found, R304.5.3

Compliance	Description	Data	Compliance	Description	Data
N/A	Ramp Length (in)	93.0	Yes	BlendTrans Slope (%)	2.2
Yes	Ramp Width (in)	48.0	No	BlendTrans XSlope (%)	3.0
N/A	Flare Type LT	N/A	N/A	Flare Type RT	N/A
N/A	Flare Slope LT (%)	N/A	N/A	Flare Slope RT (%)	N/A
N/A	Flare Traversable LT?	N/A	N/A	Flare Traversable RT?	N/A
N/A	Landing Length (in)	N/A	N/A	DWS Provided?	N/A
N/A	Landing Width (in)	N/A	N/A	DWS Contrast?	N/A
N/A	Landing Slope (%)	N/A	N/A	DWS Length (in)	N/A
N/A	Landing X Slope (%)	N/A	N/A	DWS Full Width?	N/A
N/A	Landing Curb? (Y/N)	N/A	N/A	DWS Offset (in)	N/A
N/A	Shared Landing?	N/A			
N/A	Gutter Ponding?	N/A	N/A	Gutter Slope (%)	N/A
N/A	Gutter Lip Ht (in)	0.5	N/A	Gutter X Slope (%)	N/A
N/A	Painted X Walk1?	No	N/A	Painted X Walk2?	N/A
	X Walk 1 Direction	To NW		X Walk 2 Direction	N/A
	X Walk 1 Width (in)	N/A		X Walk 2 Width (in)	N/A
	X Walk 1 Slope (%)	3.2		X Walk 2 Slope (%)	N/A
	X Walk 1 X Slope (%)	1.2		X Walk 2 X Slope (%)	N/A

N/A	Ramp inside XWalk1?	N/A	N/A	Ramp inside XWalk2?	N/A
	Road Slope (%)	1.2		Clear Space?	N/A
	Road X Slope (%)	3.2	N/A	Clear Space to XWalk (in)	N/A
N/A	Any Obstructions?	N/A	N/A	Storm Grate/Utility Hazard?	N/A
	Obstruction Type			Storm Grate/Utility Type	
		N/A			N/A
			Yes	Surface Condition? (G/P)	Good
			No	Curb Slope (%)	5.8

Remove & Replace Curb Ramp With Two New Directional Ramps or Equivalent.
