# Access Compliance Report

## Public Rights-of-Way

### (Curb Ramps)

Intersection ID: 2710	Main Street: FAIRVISTA_DR	Cross Street: QUEENSBURY_CT	Location: NE
ADA ID: EAF3EFC1EAD7	Ramp Type: PerpDiag	Initial Pass/Fail: Pass	Overall Compliance: No
			Severity Score: 30.25

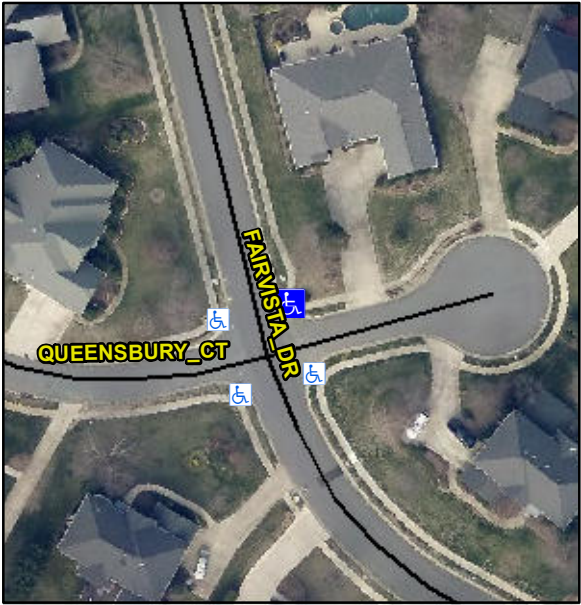
Possible Solutions:		<b>Compliance</b>	<b>Description</b>	<b>Data</b>	
	Remove & Replace Curb Ramp With Two New Directional Ramps or Equivalent. Remove & Replace Gutter.		<b>Compliance</b>	<b>Description</b>	<b>Data</b>	
			N/A	Ramp Length (in)	74.0	No
			Yes	Ramp Width (in)	51.0	No
			N/A	Flare Type LT	Sloped	N/A
			N/A	Flare Slope LT (%)	2.7	Yes
			N/A	Flare Traversable LT?	Yes	N/A
			No	Landing Length (in)	N/A	No
			No	Landing Width (in)	N/A	No
			No	Landing Slope (%)	N/A	N/A
			No	Landing X Slope (%)	N/A	N/A
			N/A	Landing Curb? (Y/N)	No	N/A
			N/A	Shared Landing?	No	
			Yes	Gutter Ponding?	No	Yes
			No	Gutter Lip Ht (in)	0.5	No
			N/A	Painted X Walk1?	No	N/A
				X Walk 1 Direction	To W	
			N/A	X Walk 1 Width (in)	N/A	N/A
				X Walk 1 Slope (%)	6.2	
				X Walk 1 X Slope (%)	4.9	
			N/A	Ramp inside XWalk1?	N/A	N/A
				Road Slope (%)	1.9	N/A

Road X Slope (%)	3.4	N/A
			Yes	Any Obstructions?	No	Yes
				Obstruction Type		
					N/A	N/A
			Yes	Surface Condition? (G/P)		Good

**Not Found, R304.2.2, R304.5.3, R304.2.1, R304.2.2-Perp, R304.3.2-Para, R305, R302.7.2**

**Remove & Replace Curb Ramp With Two New Directional Ramps or Equivalent. Remove & Replace Gutter.**
