Access Compliance Report

Public Rights-of-Way

(Curb Ramps)

Intersection ID: 52487	Main Street: WHITEHALL_EXECUTIVE_CENTER_DR	Cross Street: ORLICK_DR	Location: N
ADA ID: EAFB243EC9BB	Ramp Type: Perp	Initial Pass/Fail: Fail	Overall Compliance: No
Severity Score: 13.75			
Codes/Mitigation Info/Possible Solution		Field Measurements/Component Compliance

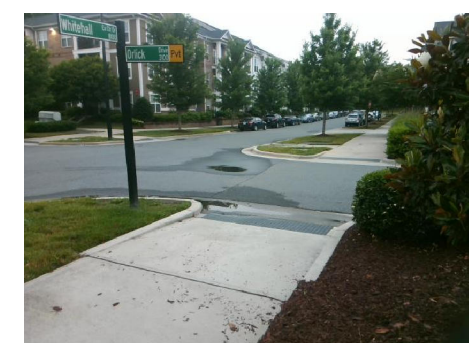
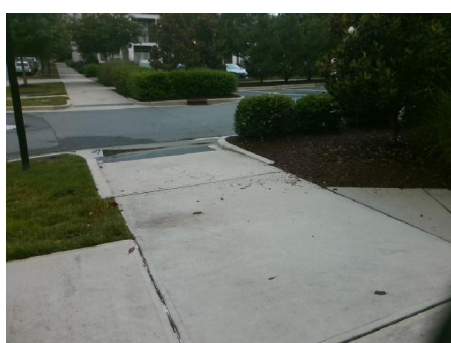
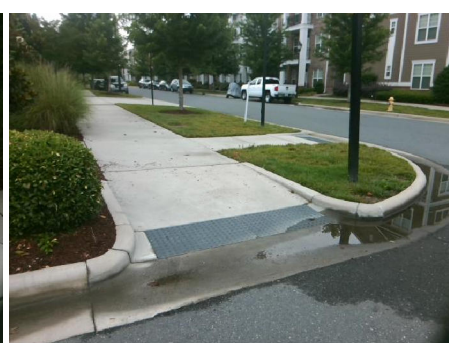
Not Found, R304.2.2, R304.5.3

Compliance	Description	Data	Compliance	Description	Data
N/A	Ramp Length (in)	111.0	No	Ramp Slope (%)	8.6
Yes	Ramp Width (in)	95.0	No	Ramp XSlope (%)	2.3
N/A	Flare Type LT	N/A	N/A	Flare Type RT	N/A
N/A	Flare Slope LT (%)	N/A	N/A	Flare Slope RT (%)	N/A
N/A	Flare Traversable LT?	N/A	N/A	Flare Traversable RT?	N/A
N/A	Landing Length (in)	N/A	N/A	DWS Provided?	N/A
N/A	Landing Width (in)	N/A	N/A	DWS Contrast?	N/A
N/A	Landing Slope (%)	N/A	N/A	DWS Length (in)	N/A
N/A	Landing X Slope (%)	N/A	N/A	DWS Full Width?	N/A
N/A	Landing Curb? (Y/N)	N/A	N/A	DWS Offset (in)	N/A
N/A	Shared Landing?	N/A			
N/A	Gutter Ponding?	N/A	N/A	Gutter Slope (%)	N/A
N/A	Gutter Lip Ht (in)	N/A	N/A	Gutter X Slope (%)	N/A
N/A	Painted X Walk1?	No	N/A	Painted X Walk2?	N/A
	X Walk 1 Direction	To SW		X Walk 2 Direction	N/A
N/A	X Walk 1 Width (in)	N/A	N/A	X Walk 2 Width (in)	N/A
	X Walk 1 Slope (%)	0.8		X Walk 2 Slope (%)	N/A
	X Walk 1 X Slope (%)	1.9		X Walk 2 X Slope (%)	N/A

N/A	Ramp inside XWalk1?	N/A	N/A	Ramp inside XWalk2?	N/A
	Road Slope (%)	N/A	N/A	Clear Space?	N/A
	Road X Slope (%)	N/A	N/A	Clear Space to XWalk (in)	N/A
N/A	Any Obstructions?	N/A	N/A	Storm Grate/Utility Hazard?	N/A
	Obstruction Type			Storm Grate/Utility Type	
		N/A			N/A
			Yes	Surface Condition? (G/P)	Good

Remove & Replace Entire Ramp.
