## **Access Compliance Report Public Rights-of-Way** (Curb Ramps)

Intersection ID: 12416 Main Street: CHESTNUT AV **Cross Street: THOMAS AV** Location: NW ADA ID: EAFC368985D4 Ramp Type: PerpDiag Initial Pass/Fail: Pass **Overall Compliance: No Severity Score:** 20

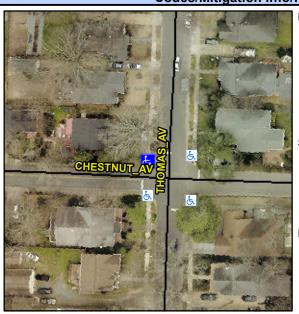
Compliance Description		Data	a Compliance Description		Data
N/A	Ramp Length (in)	73.0	Yes	Ramp Slope (%)	8.0
Yes	Ramp Width (in)	53.0	Yes	Ramp XSlope (%)	1.7
N/A	Flare Type LT	Sloped	N/A	Flare Type RT	N/A
N/A	Flare Slope LT (%)	1.5	N/A	Flare Slope RT (%)	2.4
N/A	Flare Traversable LT?	No	N/A	Flare Traversable RT?	No
No	Landing Length (in)	N/A	No	DWS Provided?	No
No	Landing Width (in)	N/A	N/A	DWS Contrast?	No
No	Landing Slope (%)	N/A	N/A	DWS Length (in)	N/A
No	Landing X Slope (%)	N/A	N/A	DWS Full Width?	No
N/A	Landing Curb? (Y/N)	No	N/A	DWS Offset (in)	N/A
N/A	Shared Landing?	N/A			
Yes	Gutter Ponding?	No	Yes	Gutter Slope (%)	1.3
Yes	Gutter Lip Ht (in)	0.0	No	Gutter X Slope (%)	3.4
N/A	Painted X Walk1?	No	N/A	Painted X Walk2?	No
	X Walk 1 Direction	To S		X Walk 2 Direction	То Е
N/A	X Walk 1 Width (in)	N/A	N/A	X Walk 2 Width (in)	N/A
	X Walk 1 Slope (%)	2.2		X Walk 2 Slope (%)	6.5
	X Walk 1 X Slope (%)	3.7		X Walk 2 X Slope (%)	0.5

N/A	Ramp inside XWalk1?	N/A	N/A	Ramp inside XWalk2?	N/A
	Road Slope (%)	3.4	N/A	Clear Space?	Yes
	Road X Slope (%)	2.3	N/A	Clear Space to XWalk (in)	N/A
Yes	Any Obstructions?	No	Yes	Storm Grate/Utility Hazard?	No
	Obstruction Type		l	Storm Grate/Utility Type	
		N/A			N/A
			ı

Possible Solutions: Remove & Replace Curb Ramp With Two New Directional Ramps or Equivalent. Remove & Replace Gutter. Surveyor Notes: N/A PROW/ADA: R304.2.1, R304.2.2-Perp, R304.3.2-Para, R304.5.3, R305
