Access Compliance Report

Public Rights-of-Way

(Curb Ramps)

Intersection ID: 46756	Main Street: TAHOE_DR	Cross Street: PONTCHATRAIN_AV	Location: NE
ADA ID: EAFC815FD934	Ramp Type: PerpDiag	Initial Pass/Fail: Fail	Overall Compliance: No
		Severity Score: 22.5

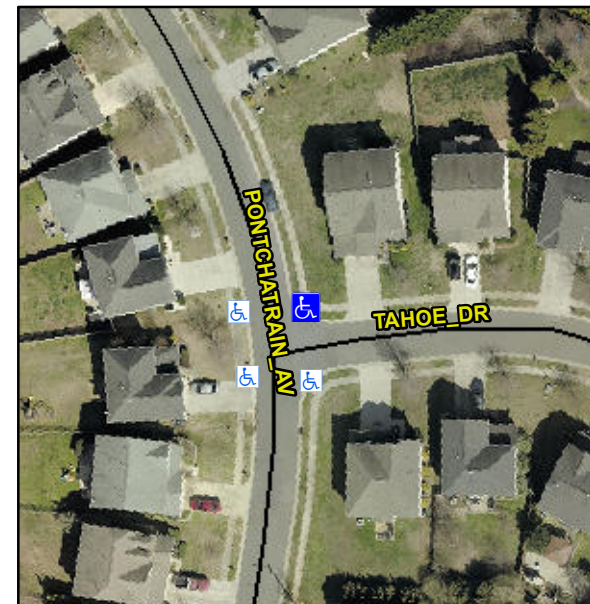
Compliance	Description	Data	Compliance	Description	Data
N/A	Ramp Length (in)	48.0	No	Ramp Slope (%)	9.4
No	Ramp Width (in)	46.0	No	Ramp XSlope (%)	3.2
N/A	Flare Type LT	N/A	N/A	Flare Type RT	N/A
N/A	Flare Slope LT (%)	N/A	N/A	Flare Slope RT (%)	N/A
N/A	Flare Traversable LT?	N/A	N/A	Flare Traversable RT?	N/A
N/A	Landing Length (in)	N/A	N/A	DWS Provided?	N/A
N/A	Landing Width (in)	N/A	N/A	DWS Contrast?	N/A
N/A	Landing Slope (%)	N/A	N/A	DWS Length (in)	N/A
N/A	Landing X Slope (%)	N/A	N/A	DWS Full Width?	N/A
N/A	Landing Curb? (Y/N)	N/A	N/A	DWS Offset (in)	N/A
N/A	Shared Landing?	N/A			
N/A	Gutter Ponding?	N/A	N/A	Gutter Slope (%)	N/A
N/A	Gutter Lip Ht (in)	N/A	N/A	Gutter X Slope (%)	N/A
N/A	Painted X Walk1?	No	N/A	Painted X Walk2?	No
	X Walk 1 Direction	To W		X Walk 2 Direction	To S
N/A	X Walk 1 Width (in)	N/A	N/A	X Walk 2 Width (in)	N/A
	X Walk 1 Slope (%)	4.8		X Walk 2 Slope (%)	2.3
	X Walk 1 X Slope (%)	5.2		X Walk 2 X Slope (%)	1.8

N/A	Ramp inside XWalk1?	N/A	N/A	Ramp inside XWalk2?	N/A
	Road Slope (%)	4.0	N/A	Clear Space?	N/A
	Road X Slope (%)	5.6	N/A	Clear Space to XWalk (in)	N/A
N/A	Any Obstructions?	N/A	N/A	Storm Grate/Utility Hazard?	N/A
	Obstruction Type			Storm Grate/Utility Type	
		N/A			N/A
			Yes	Surface Condition? (G/P)	Good

Possible Solutions:

Remove & Replace Curb Ramp With Two New Directional Ramps or Equivalent.
